# Technical Service Information

## CHRYSLER A604

### NEW PRNODL AND NEUTRAL SAFETY SWITCHES

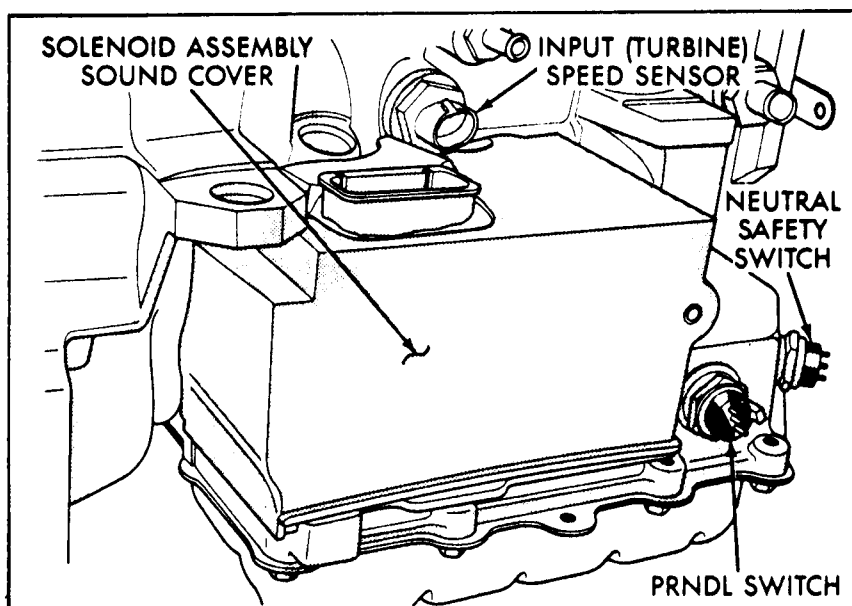
**CHANGE:** PRNODL Switch and Neutral Safety Switch have been changed for the 1990 model year, as well as the vehicle wiring harness connectors. Refer to Figure 17 for location of switches on the transaxle.

**REASON:** Positive locking mechanism, with a weathertight seal, to prevent the connection from becoming loose.

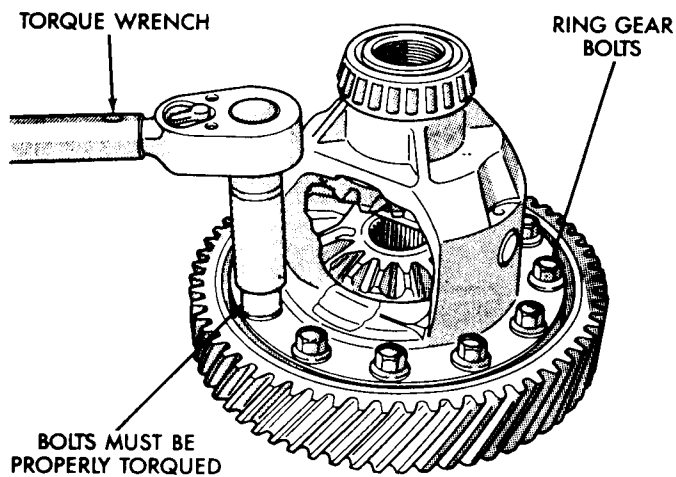
**Fig. 15—Torque New Ring Gear Bolts to 95 N·m (70 Ft. Lbs.)**

**CAUTION:** Always install NEW ring gear bolts. Bolts must be properly torqued.

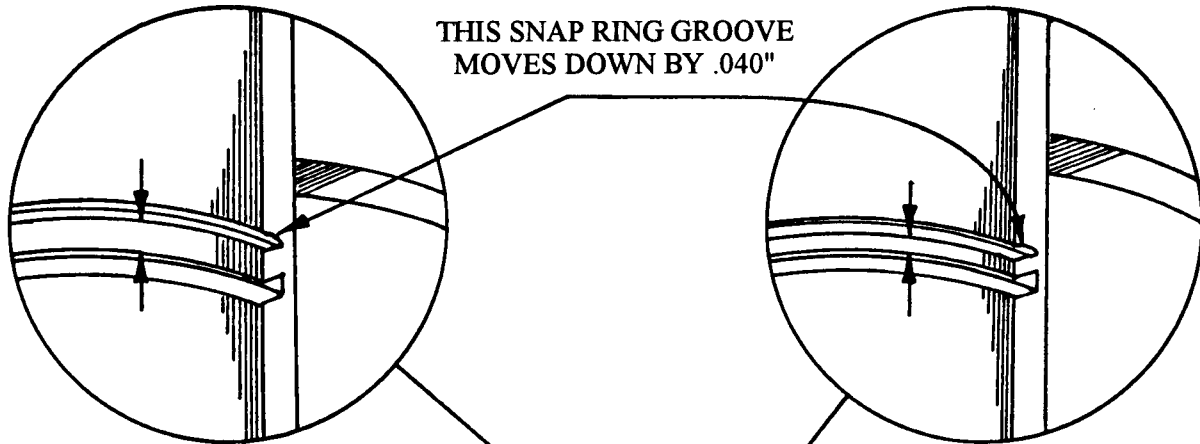
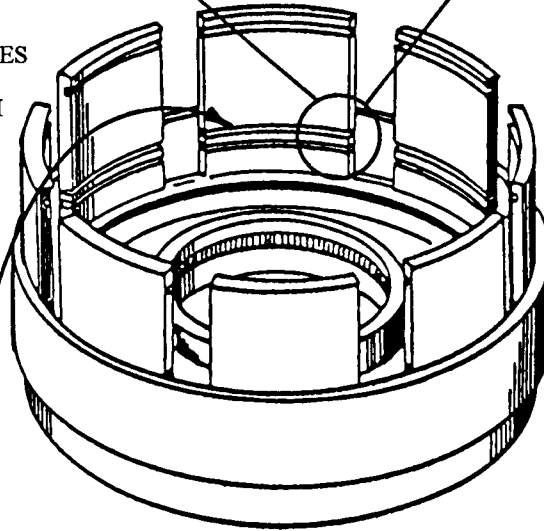
Figure 16

THIS SNAP RING GROOVE  
MOVES DOWN BY .040"

.123" OF DRUM MATERIAL  
BETWEEN THE SNAP RING GROOVES  
MEANS THAT THIS IS A 3 OD  
FRICTION INPUT CLUTCH DRUM

.083" OF DRUM MATERIAL  
BETWEEN THE SNAP RING GROOVES  
MEANS THAT THIS IS A 4 OD  
FRICTION INPUT CLUTCH DRUM

THE UPPER SNAP RING GROOVE WAS MOVED DOWN .040" AS A PART OF A  
DIMENSIONAL CHANGE TO ACCOMMODATE THE EXTRA STEEL AND LINED PLATE

1989 INPUT CLUTCH RETAINER.....	4431609
1990 INPUT CLUTCH RETAINER.....	4505623
