Technical Service Information

FORD AODE NO UPSHIFT

FORD AOD-E OUTPUT SHAFT RING GEAR SUPPORT AND REAR CASE BEARING IDENTIFICATION

FORD 4R70W 3-NEUTRAL SHIFT AND FORWARD CLUTCHES BURNT

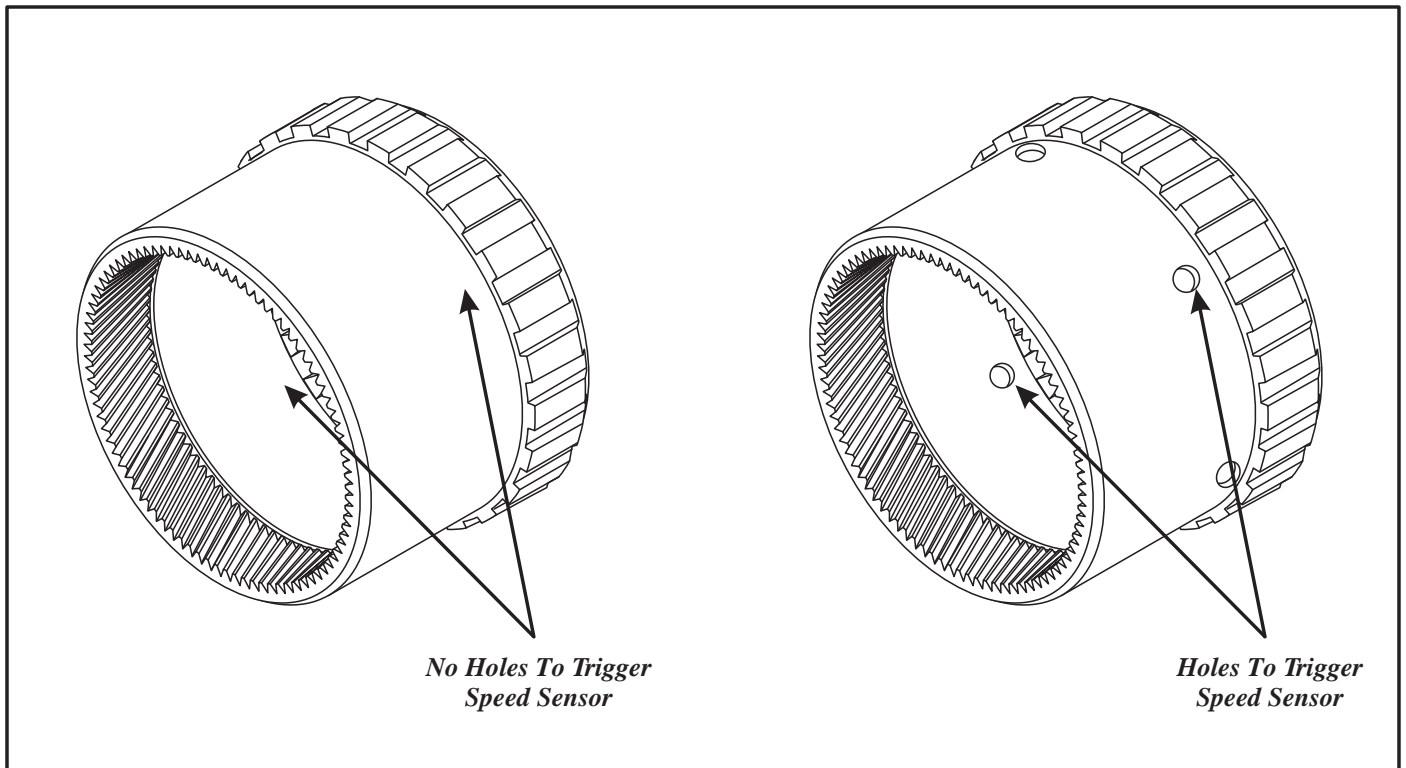
Figure 8

COMPLAINT: Since the hydraulically controlled AOD transmission and the electronically controlled AODE transmission planetary gears were the same ratios, the first thing to happen was interchange of parts which is okay to do, *except* for the internal ring gear. The internal ring gear for the AODE transmission *must* have the holes in the ring gear, to trigger the output shaft speed sensor, as shown in Figure 8.

CAUSE: The cause may be, AOD internal ring gear that has no holes to trigger the output speed sensor has been installed by mistake.

CORRECTION: Install the AODE internal ring gear with the holes to trigger the output speed sensor, as shown in Figure 8.

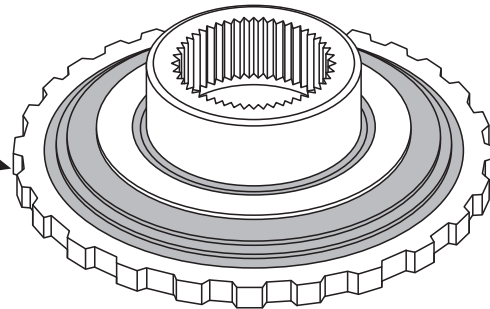
**TWO PIECE "OPEN"
REAR CASE BEARING
.113" THICKNESS
PART NO, EOAZ-7F242-A**

**DIFFERENT PROFILE ON SUPPORT
AND WILL NOT INTERCHANGE**

**RING GEAR SUPPORT
PART NO. F4AZ-7D164-A**

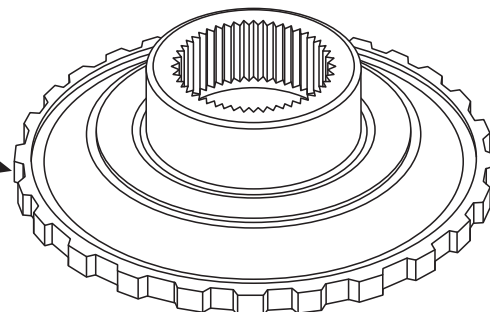
Figure 9

**THREE PIECE "CLOSED"
REAR CASE BEARING
.144" THICKNESS
PART NO, F3LY-7F242-A**

**DIFFERENT PROFILE ON SUPPORT
AND WILL NOT INTERCHANGE**

**RING GEAR SUPPORT
PART NO. F3LY-7D164-B**

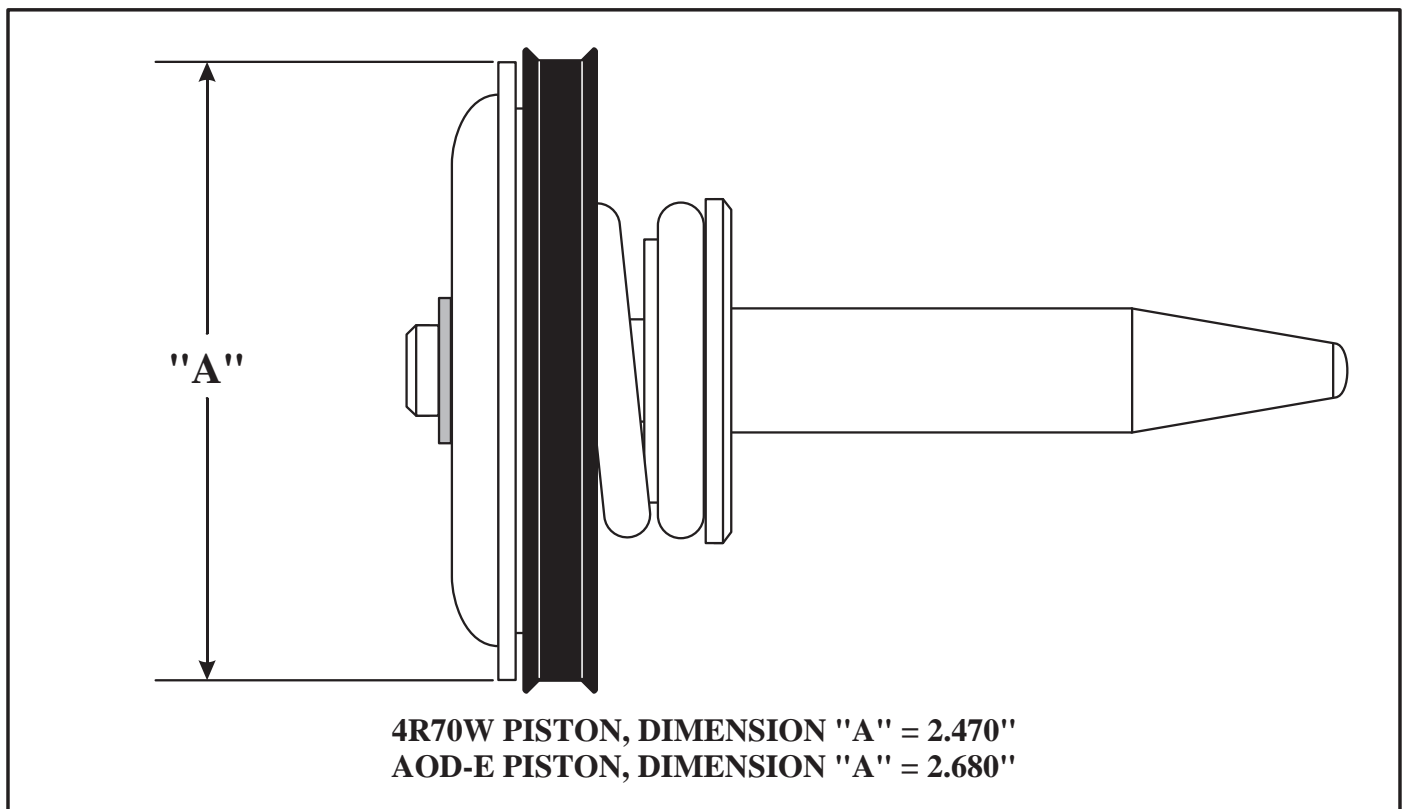
Figure 18

COMPLAINT: After overhaul, the 4R70W transmission displays a 3-neutral upshift and when the unit is disassembled, you find the forward clutches burnt.

CAUSE: The cause may be, a mis-assembled Overdrive Servo Assembly, with the "Rubber Coated Sleeve" omitted. The 4R70W transmission is calibrated with a smaller diameter overdrive servo piston than is the AOD-E transmission. To retain a common case between the two transmissions, an additional "Rubber Coated Sleeve" is required on the 4R70W Overdrive Servo Assembly, as shown in Figure 19.

CORRECTION: Install the "Rubber Coated Sleeve" in the Overdrive Servo Assembly case bore, as shown in Figure 19. If your rubber coated sleeve is missing or lost, you *must* purchase the complete Overdrive Servo Assembly, available under part number F3LY-7H188-A. It is not available individually.
Overdrive servo piston dimensions are shown in Figure 18, to identify the two different overdrive servo pistons.
