## A4LD UPDATE HANDBOOK INDEX

AUTOMATIC TRANSMISSION SERVICE GROUP  
9200 S. DADELAND BLVD. SUITE 720  
MIAMI, FLORIDA 33156  
(305) 670-4161

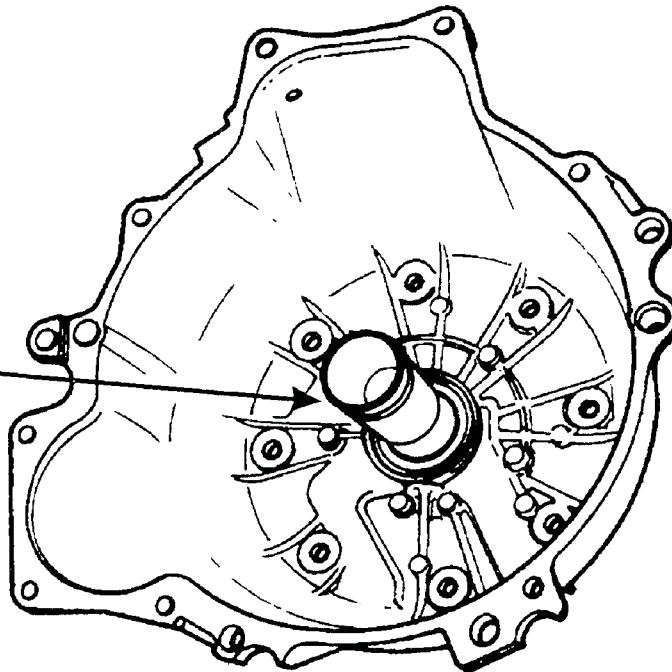
Figure 10

When assembling the pump body to the bell housing, a pump alignment tool must be used (Refer to Figure 10). Using the torque converter, will not produce proper pump alignment. If an alignment tool is not used, several problems may occur, such as:

- (1) PUMP GEARS BREAKING
- (2) PUMP WHINE
- (3) IRREGULAR BUSHING WEAR
- (4) IRREGULAR CONVERTER HUB WEAR
- (5) FRONT SEAL LEAK OR BLOW OUT

Another concern that may be attributed to the above listed problems, is replacement of the front pump bushing in the bell housing. At the factory, Ford puts an oversized bushing in the bell housing and then bores the bushing to the proper size, and establish the centerline. When a new bushing is installed, (possibly off center) pump alignment may not be possible. Ford Motor Company recommends using a new bell housing if bushing replacement is necessary. Aftermarket exchange bell housings with line bored bushings are also available.

PUMP ALIGNMENT  
TOOL  
FORD PART NUMBER  
T74P-77103-X

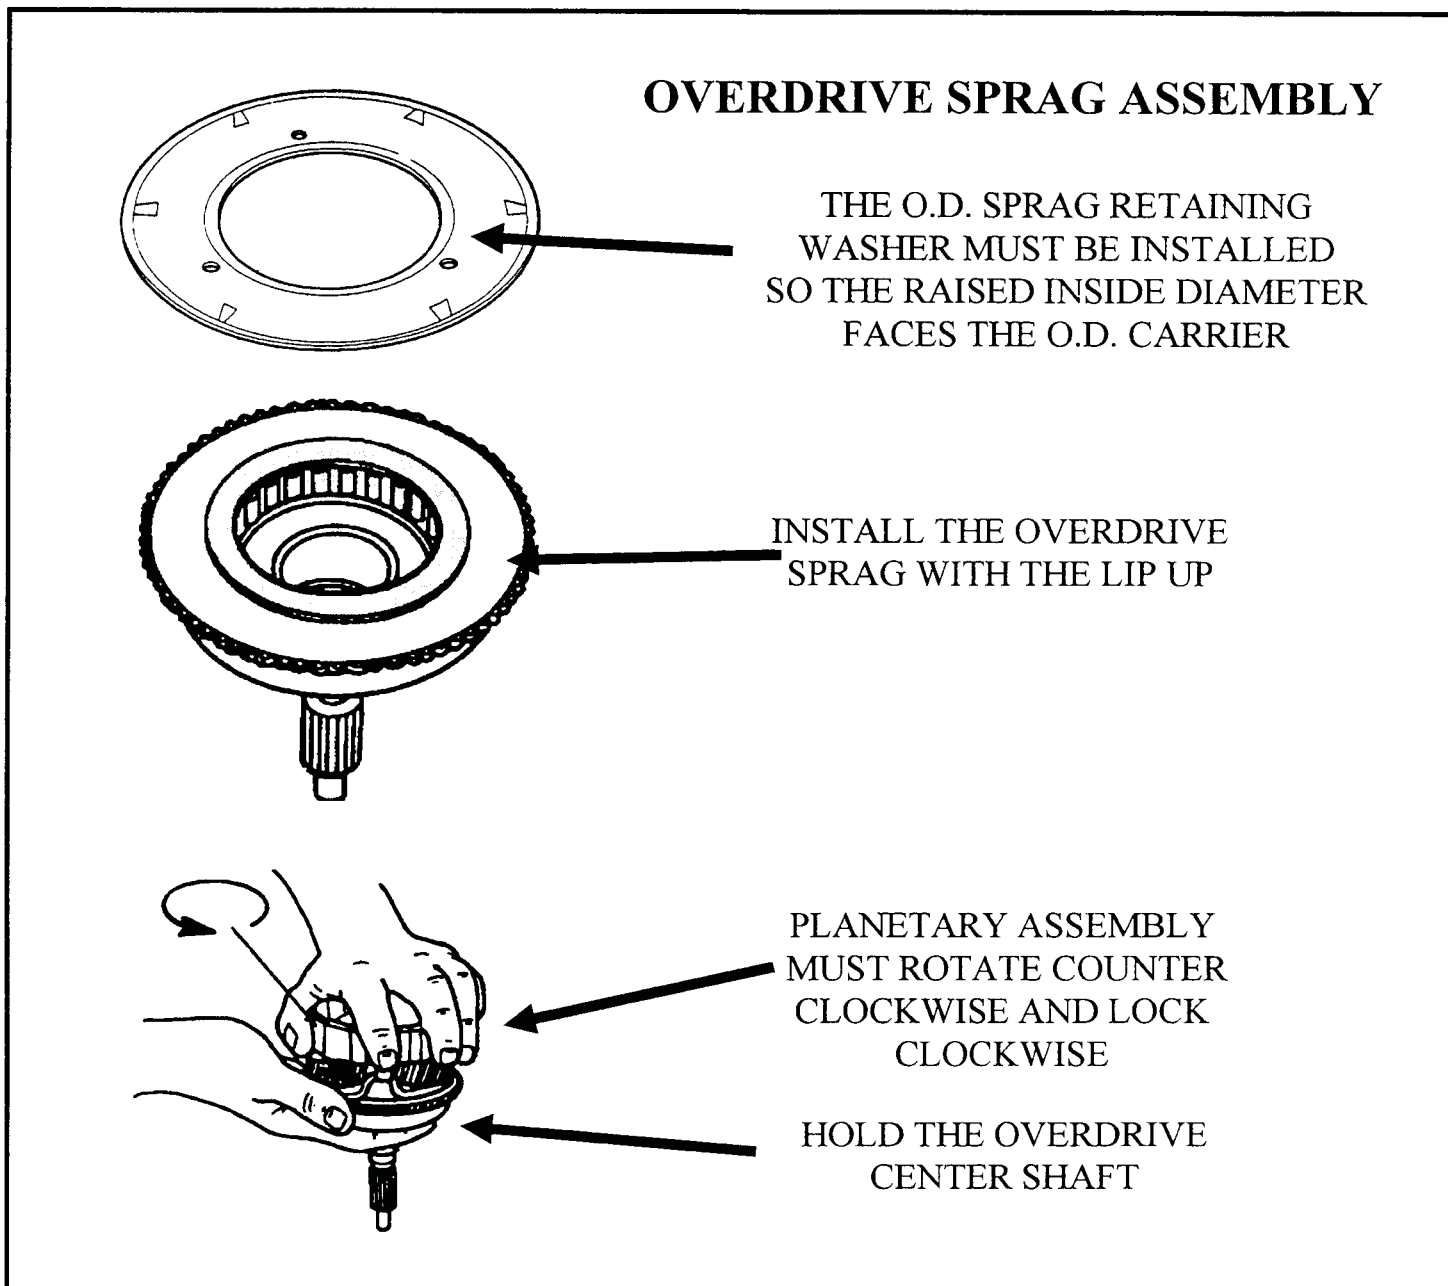
Figure 21

**COMPLAINT:** Vehicle will not move in the overdrive range, but will move in D3, 2, and 1. Another common complaint is a flair-up on a 4-3 kick down.

**CAUSE:** The cause may be the overdrive sprag in backwards or not holding (See Figure 21).

**CORRECTION:** Replace the overdrive sprag, and inspect the inner and outer sprag races for wear or damage.

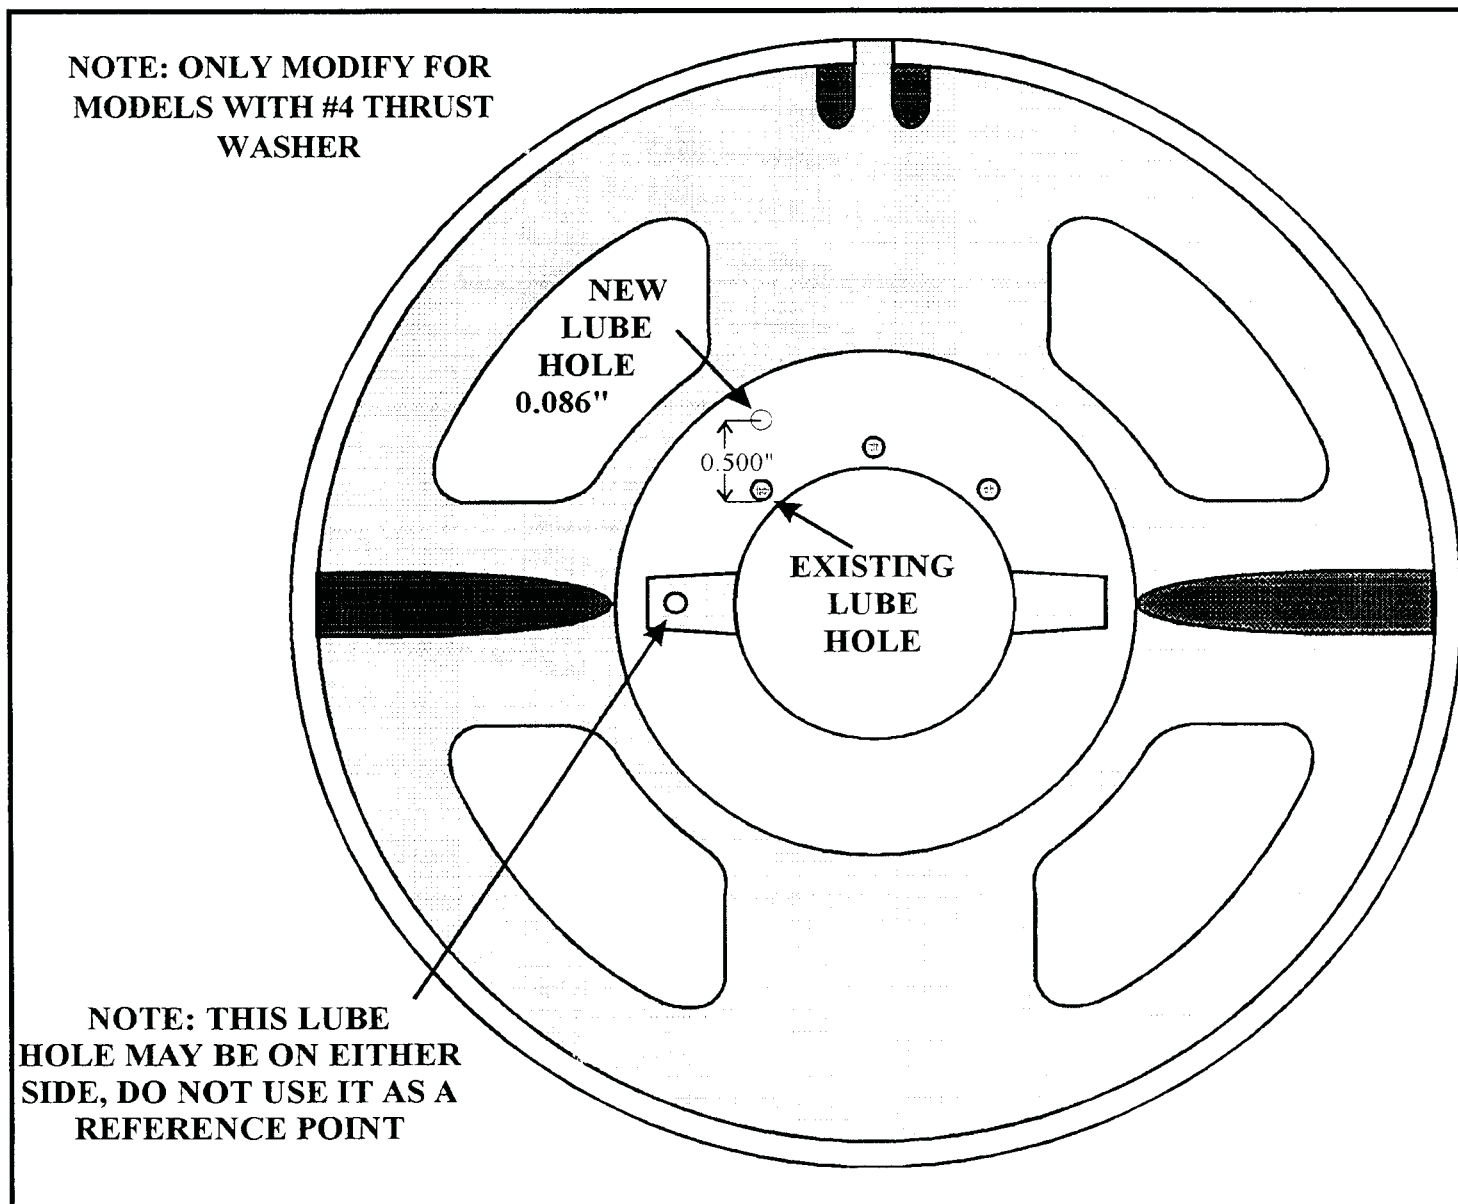
Figure 28

**COMPLAINT:** Failure of the selective #4 thrust washer between the center support and the direct drum.

**CAUSE:** The cause may be lack of lubrication to the #4 thrust washer.

**CORRECTION:** Drill a new lube hole in the center support. Measure 0.500" up from the bottom of the existing hole, drill a 0.086" hole all the way through the center support (See Figure 28).

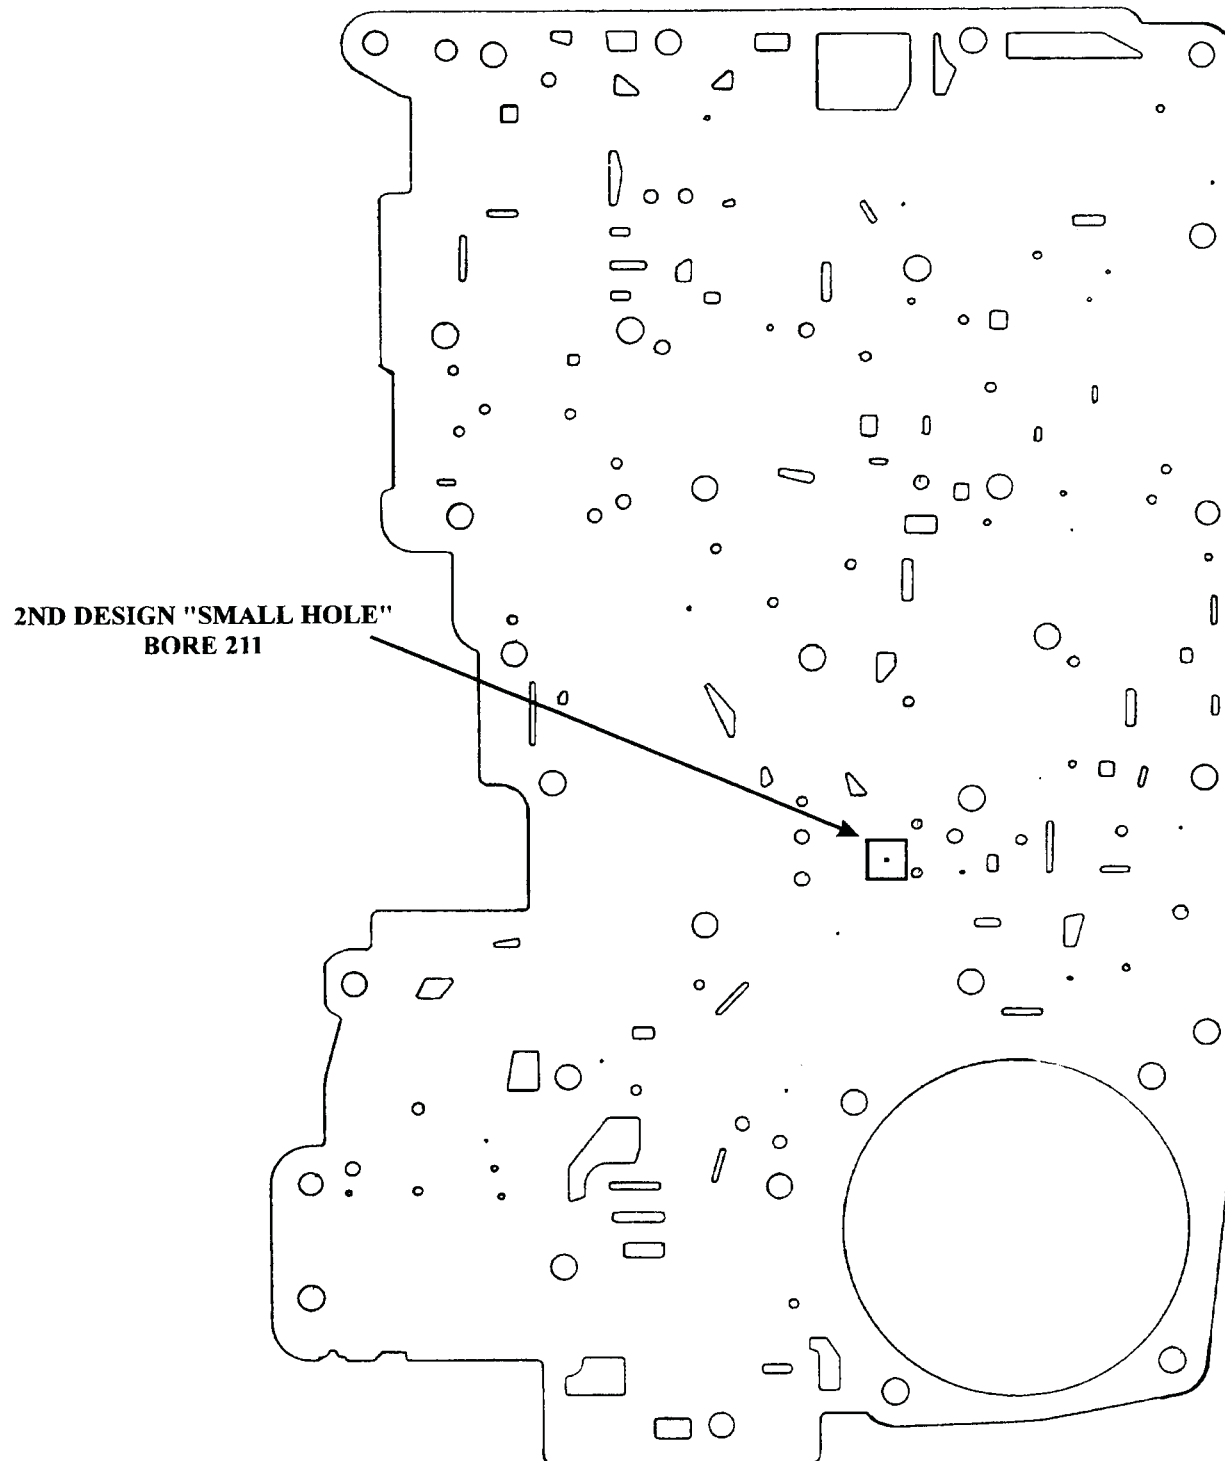
The 2nd design valve train has eliminated two springs and incorporated two spool valves into one, as shown in Figure 69. Figure 70 shows the "Small Hole" spacer plate that is required with the 2nd design line-up in bore 211.

**Note:** The 1st design bore 211 parts are not compatible with the 2nd design valve body casting, because the orifice control valve and the 1st design valve body bore are smaller in diameter

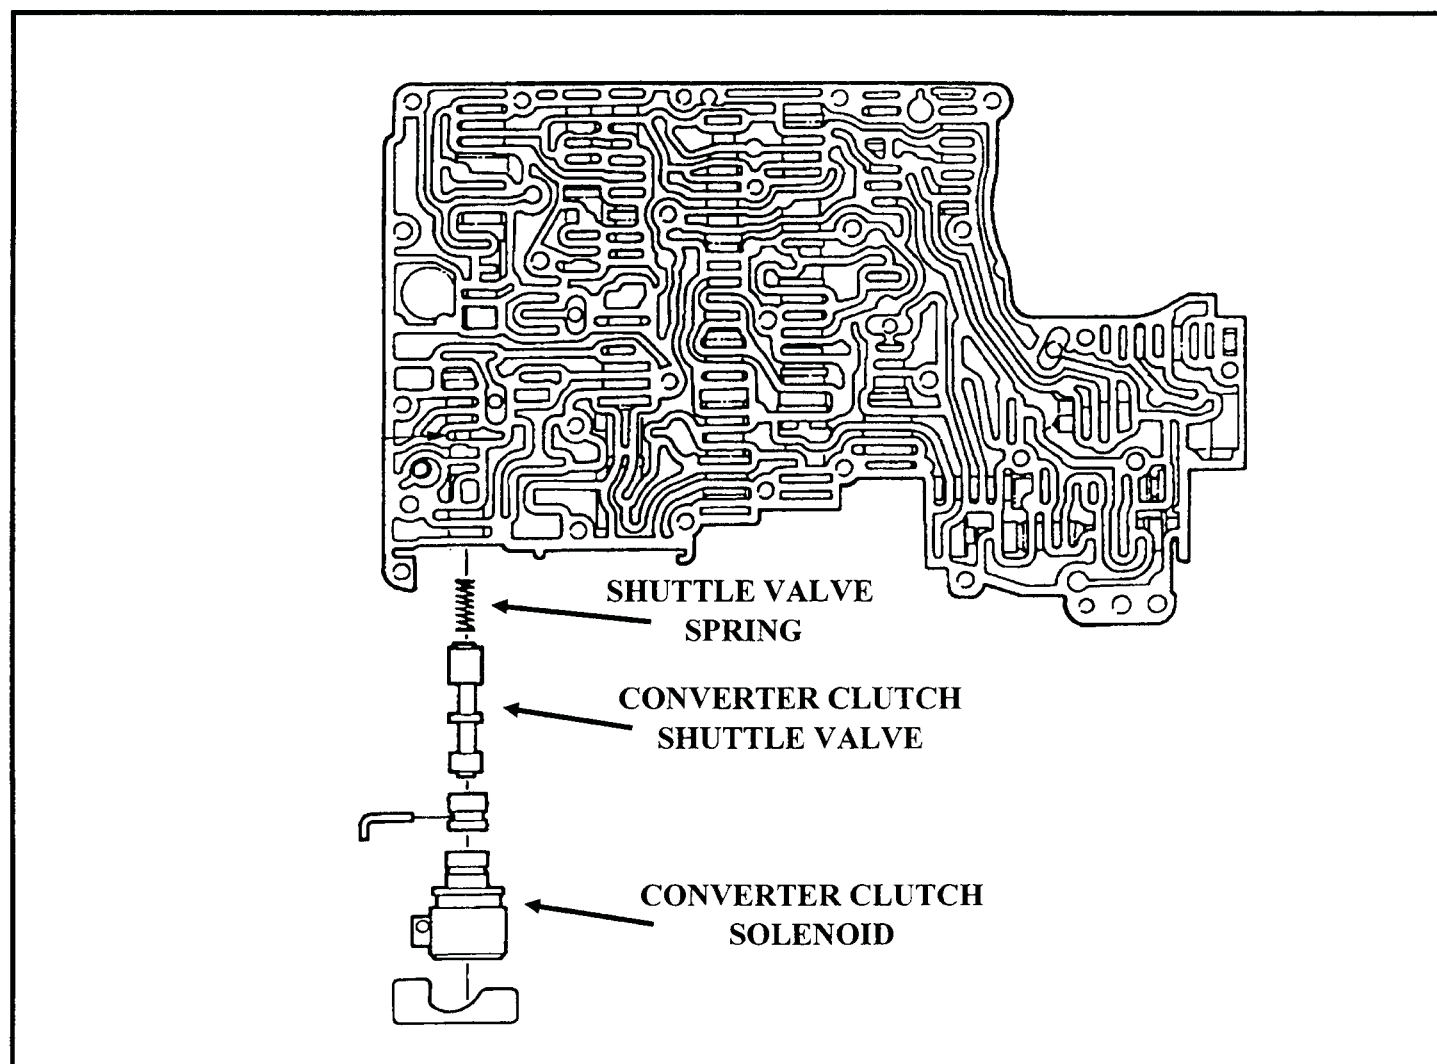
Figure 81

**COMPLAINT:** Engine stalls when the selector is placed into forward or reverse.

**CAUSE:** The cause may be a broken converter clutch shuttle valve spring.

**CORRECTION:** Replace the broken converter clutch shuttle valve spring with updated spring (See Figure 81).

Shuttle Valve Spring.....E5TZ-7L490-A
