MERCEDES 722.3 AND 722.4

Technical Service Information

MERCEDES 722.3 722.4

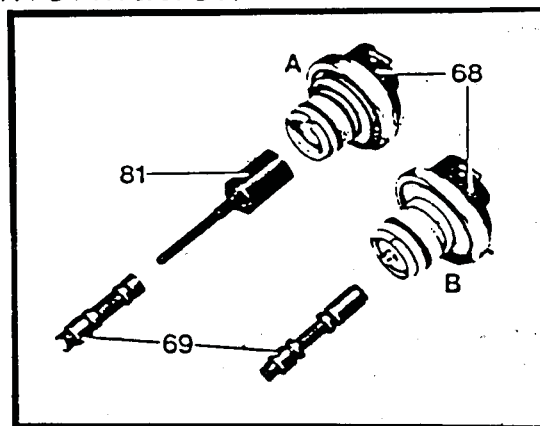
Vacuum control unit version "B" has been installed up to February 1981. Starting February 1981 the vacuum control unit with the thrust pin for heat expansion compensation version "A" is installed.

Update to the late version on overhaul

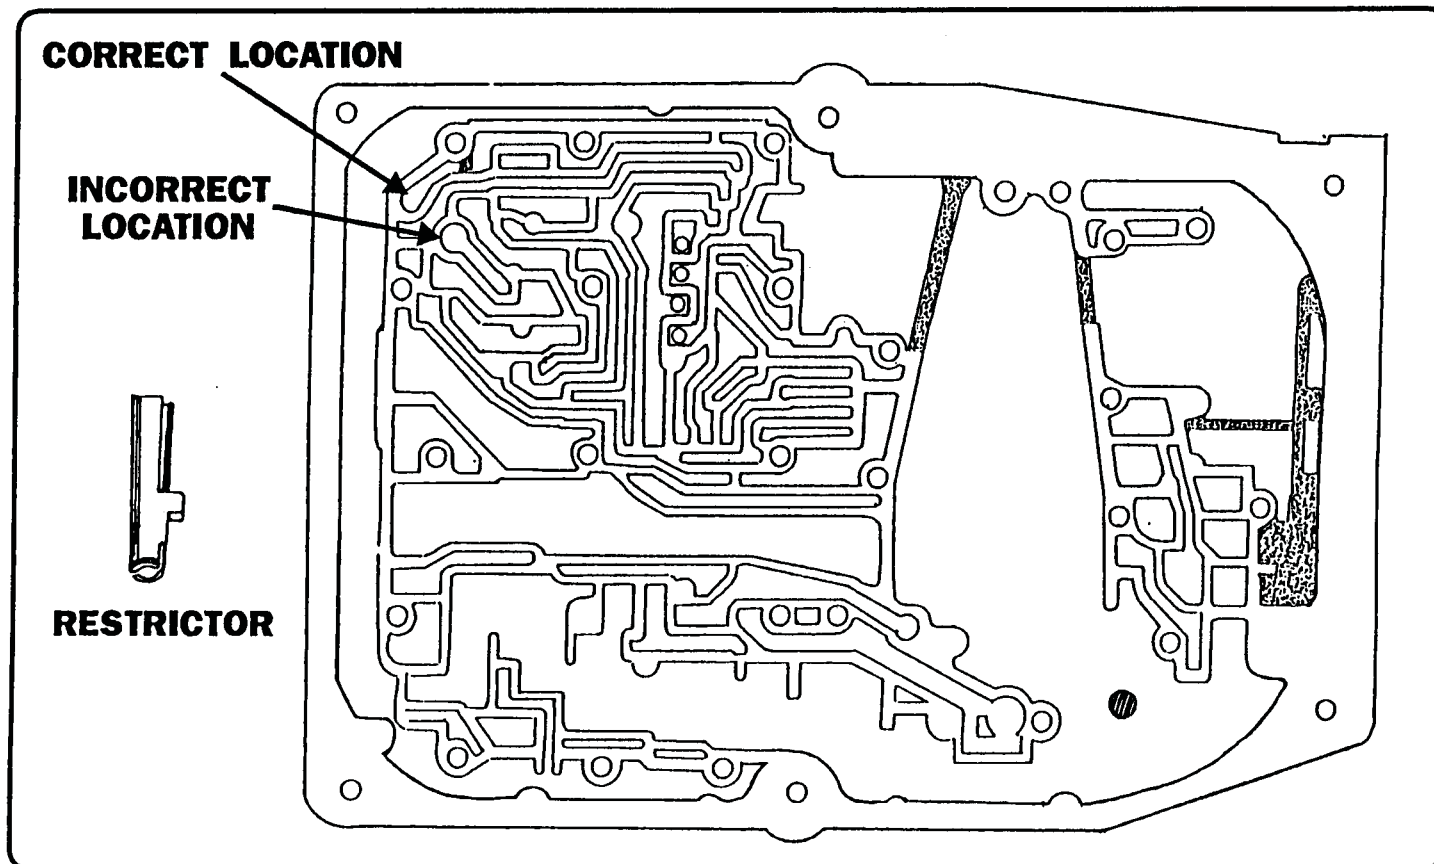
Figure 1

MERCEDES 722.4 HARSH REVERSE AFTER REBUILD CHECK VALVE IN PUMP OK

COMPLAINT: Some 190 series transmissions may experience a harsh reverse engagement into reverse after an overhaul. All forward ranges are ok and modulating pressure is within specifications.

CAUSE: The reverse feed passage is unrestricted, allowing too much oil volume to the reverse clutches.

CORRECTION: Install the Mercedes tapered oil restrictor Part no. 123 277 0319. into the transmission case as shown in Figure 1. Note that the restrictor goes in tapered end first and fits snug in the case.
