Cleanness of DI Engine Fuel System and Service Procedures

DI ENG SM - 2004.4

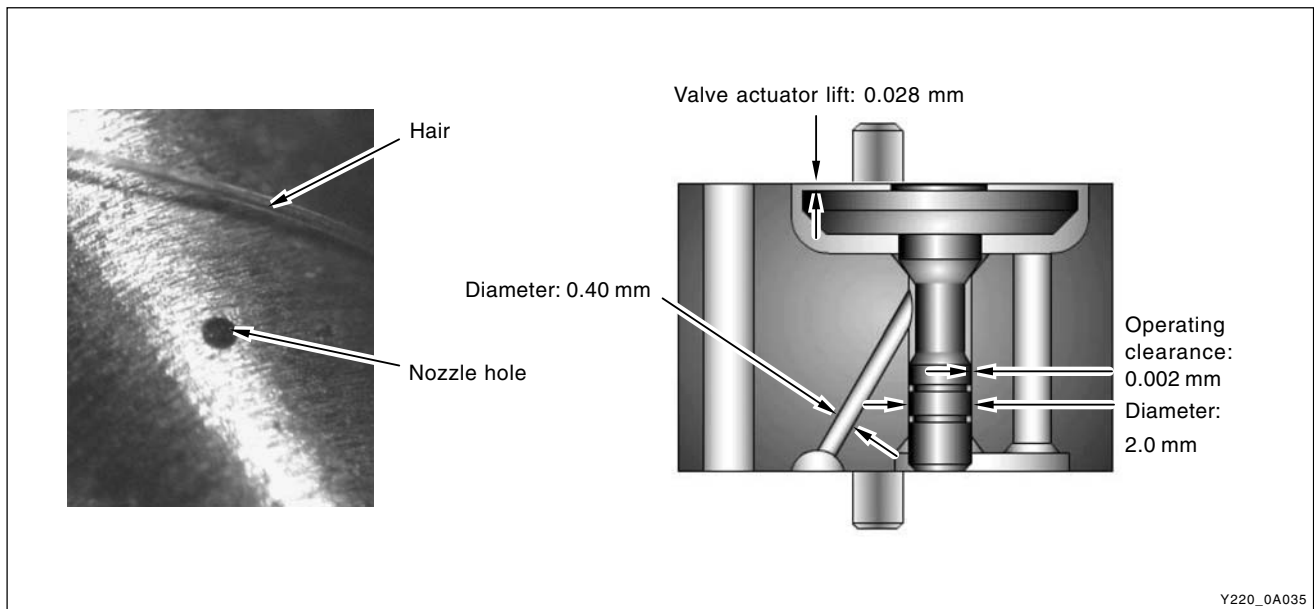
You can compare the thickness of injector nozzle hole and hair as shown in below figure (left side). The right side figure shows the clearance between internal operating elements.

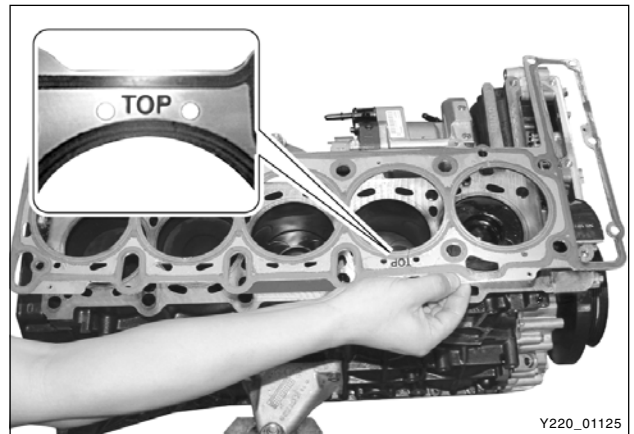
- Replace the cylinder head gasket with new one. Make sure to place the "TOP" mark upward.
- Put the steel gasket on the cylinder block and position the cylinder head.

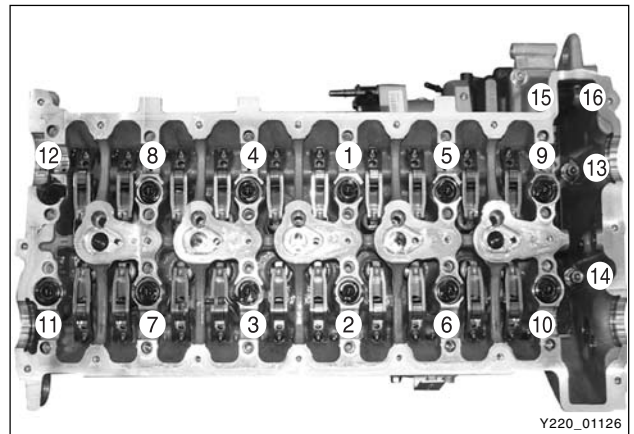
- Tighten the cylinder head bolts to specified torque and torque angle.

Tightening torque	Step 1	20 ± 2.0 Nm
	Step 2	85 ± 5.0 Nm
	Step 3	90 ± (3 times) + 10°

- Apply the oil on the bolt thread when installing.
- Always insert new washer first.
- The bolts (12) at vacuum pump side are shorter than others.

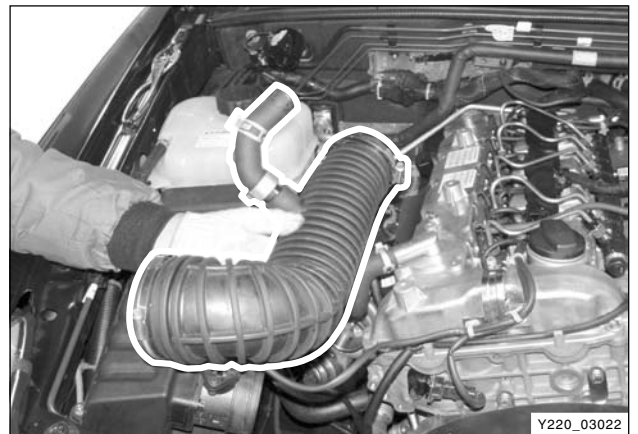
1. Loosen the clamp at intercooler side.
2. Loosen the clamp at turbo charger side.
3. Separate the hose from the oil separator and remove the intake duct.
4. Install in the reverse order of removal.

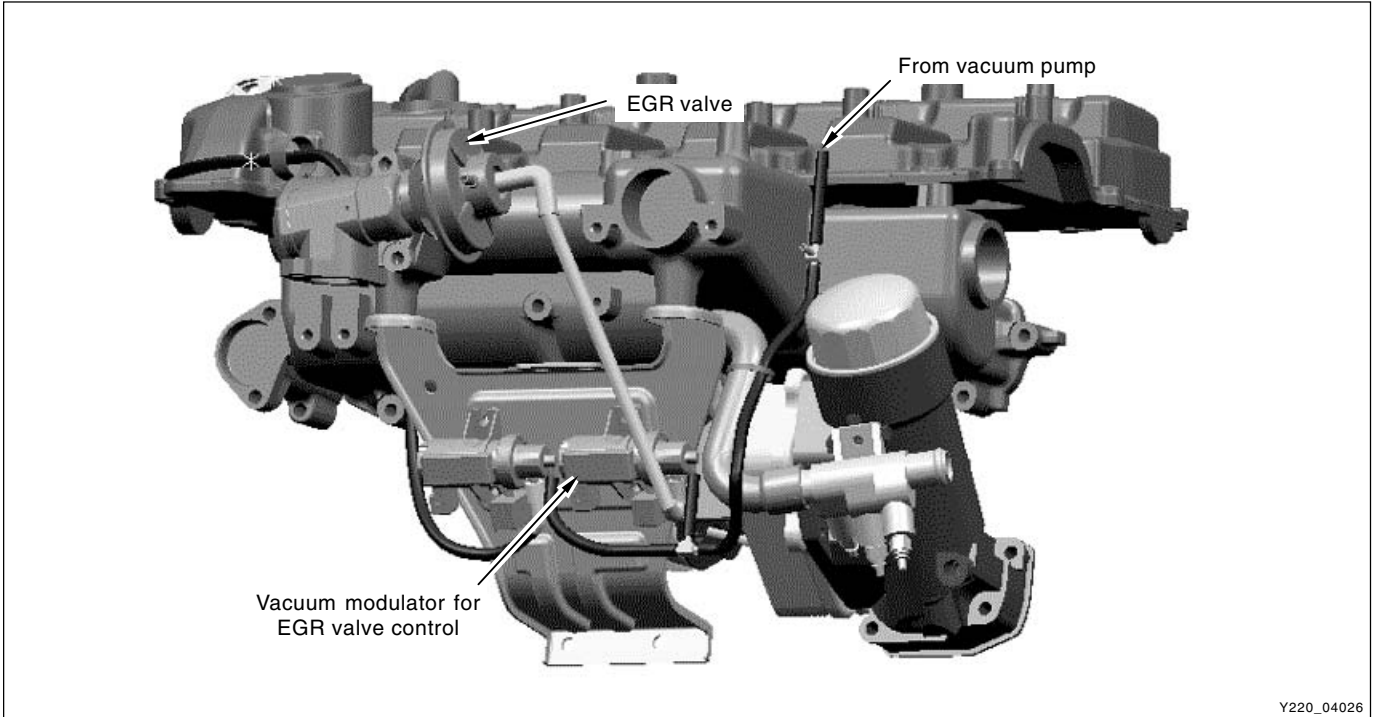
Related with EGR valve

Below figures illustrate vacuum hoses and related parts of EGR or turbo where wrong or poor connection of vacuum hose would display condition of engine irregularity and defect diagnostic codes on the scan tool.

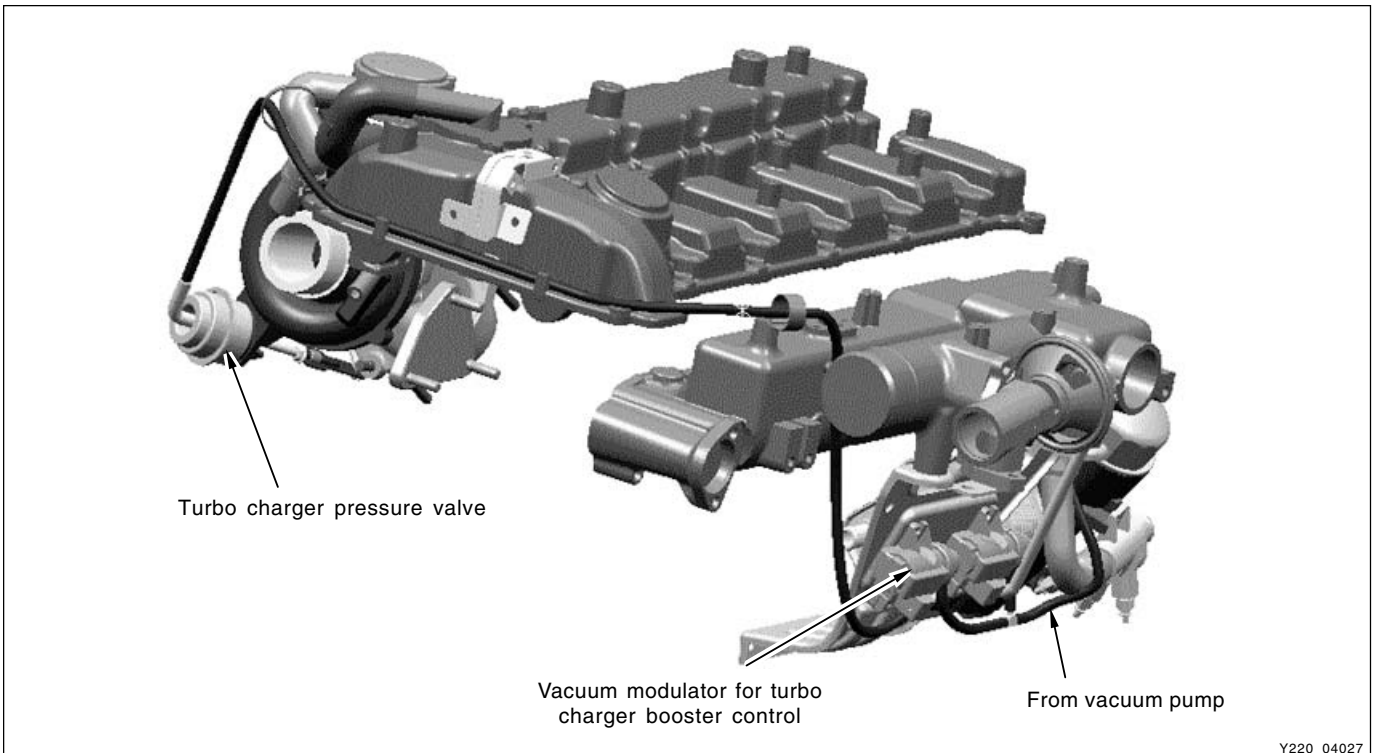
Related with turbo charger actuator

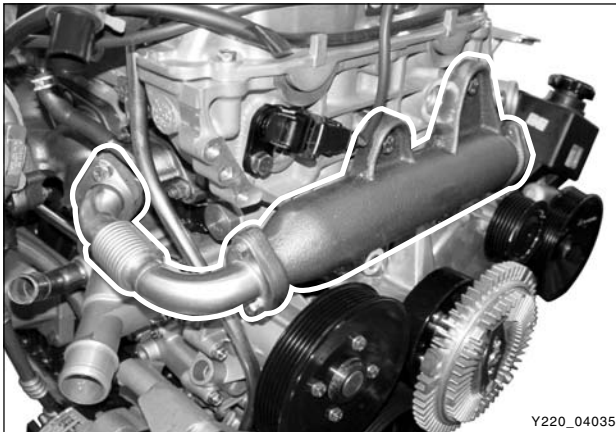
Y220_04035

2. Unscrew the bolts and remove the EGR valve (2), EGR valve #1 pipe (1) and gasket.

Tightening torque	25 ± 2.5 Nm
-------------------	-------------

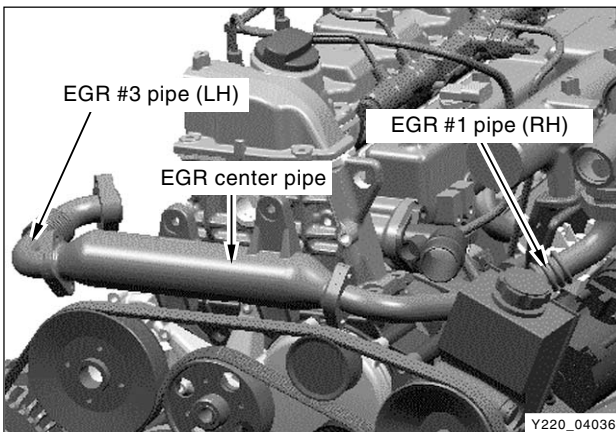
Y220_04036

3. Remove the EGR valve #1 pipe, #2 pipe, #3 pipe and gaskets from the engine.

Tightening torque	25 ± 2.5 Nm
-------------------	-------------

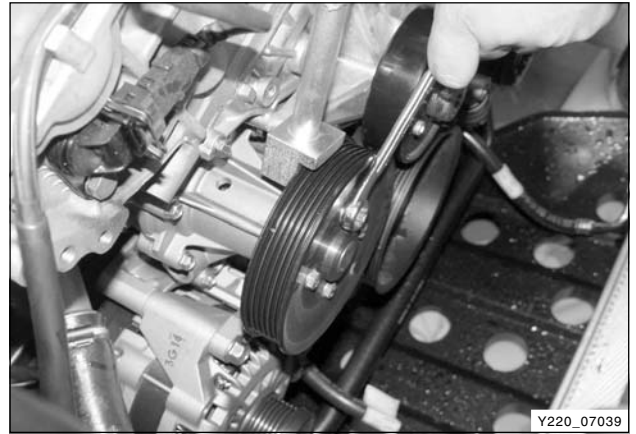
Y220_07039

5. Unscrew the bolts and remove the belt pulley while holding the belt pulley with a special tool.

Tightening torque	10 ± 1.0 Nm
-------------------	-------------

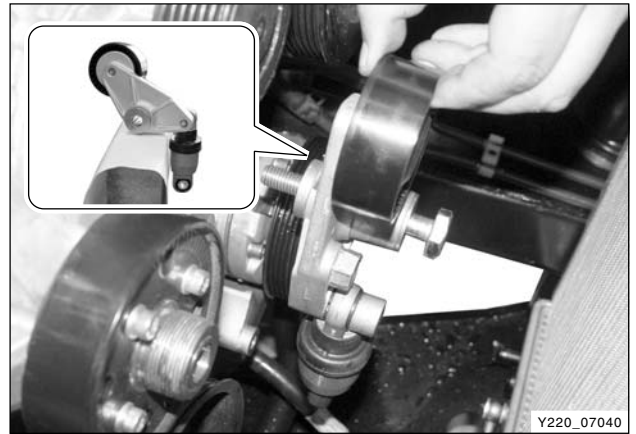
Y220_07040

6. Unscrew the upper and lower bolts and remove the auto tensioner.

Tightening torque	Nm
Upper bolt	82 ± 6.0 Nm
Lower bolt	32 ± 3.0 Nm

To prevent oil leaks, store the removed auto tensioner in upright position.

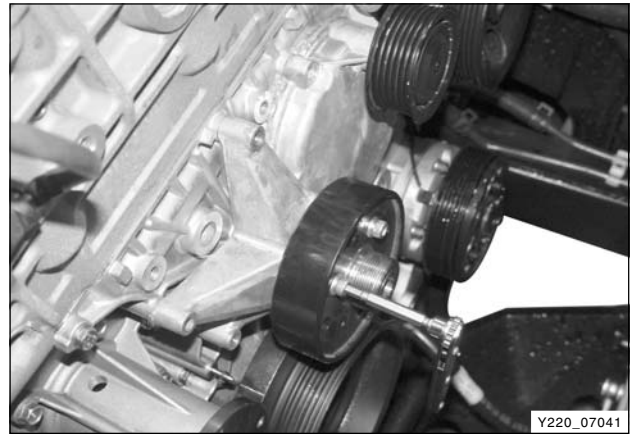
Y220_07041

7. Unscrew the bolts and remove the idle pulley.

Tightening torque	10 ± 1.0 Nm
-------------------	-------------

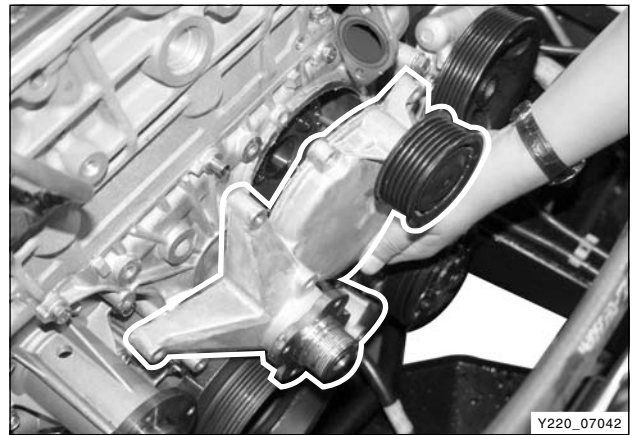
Y220_07042

8. Unscrew the bolts and remove the cooling fan bracket (timing chain cover side).

Tightening torque	10 ± 1.0 Nm
-------------------	-------------
