# Body – Overview

2011 Fiesta 08/2010 G1071723en

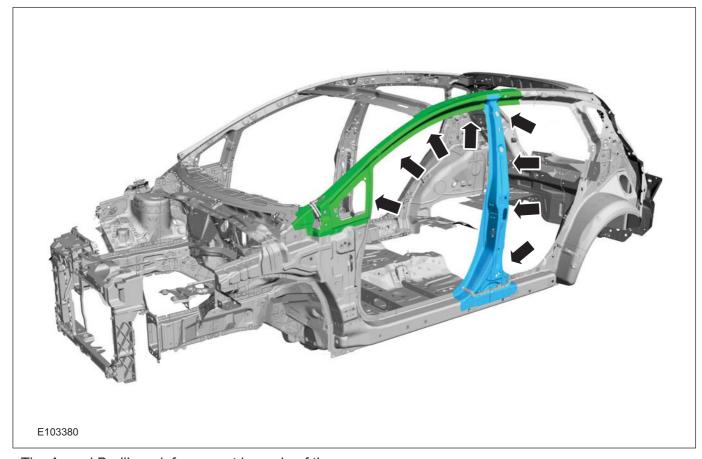
## A- and B-pillar reinforcement

The A- and B-pillar reinforcement is made of the highest strength boron steel.

These sheet metal parts can only be replaced as a complete unit during repairs and that section repairs are not possible.

Special installation and removal requirements must be observed during repairs. Special tools are also required. Relevant instructions are available in the current service literature.

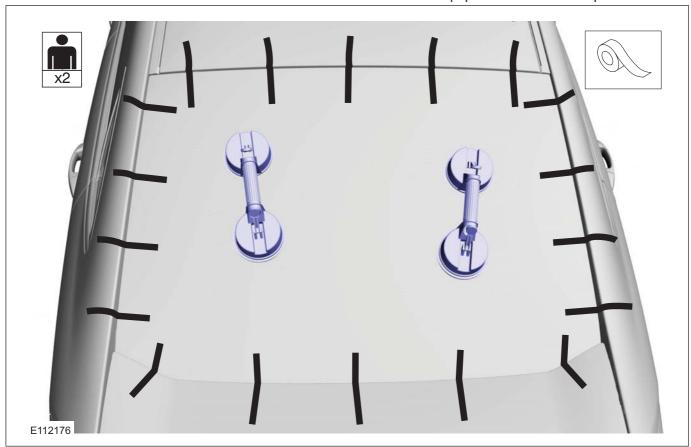
7. CAUTION: During the curing time of the polyurethane (PU) adhesive, the door windows must be left open.

Use suction cups to handle the window glass.

General Equipment: Adhesive Tape

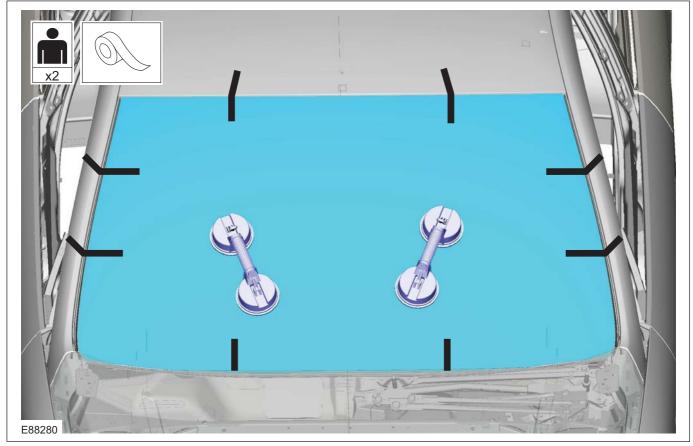
- **6.** Press firmly and evenly into position.
  - General Equipment: Direct Glazing Removal/Replacement Equipment
  - CAUTION: During the curing time of the polyurethane (PU) adhesive, the door windows must be left open.

Using tape, secure the windshield glass in the correct position until the PU adhesive has cured.

General Equipment: Adhesive Tape

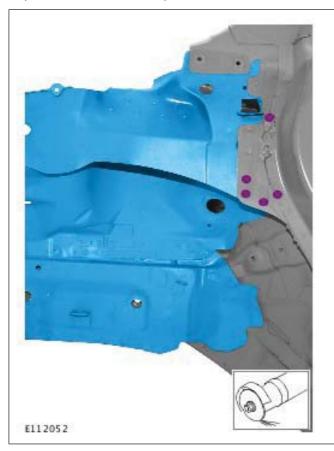
#### Color coding

Different colors or shading can be used to depict special areas and components.

- Blue: Main component which will be removed or installed. Only actual movements will be shown in blue in the diagram.
- Magenta: Materials or fixings, e.g. spot welds or adhesives.

In an assembly operation, the colors show the sequence of removal steps.

- Green: First component or the first partial replacement section.
- Blue: Second component or the second partial replacement section.
- Brown: Third component or the third partial replacement section.

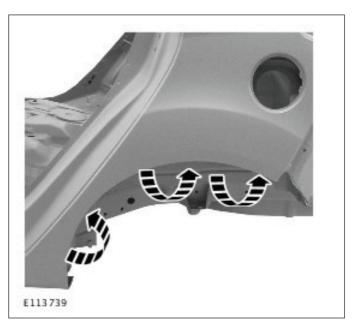
#### **Movement arrows**

Necessary work such as clinching flanges or moving lugs etc. will be represented by broken arrows.

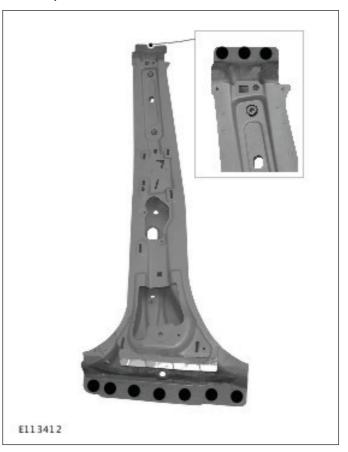
### Magnified and detailed views

If a detail cannot be clearly seen in the illustration because of its size or location, it is shown enlarged in a separate window.
