Instructions for use

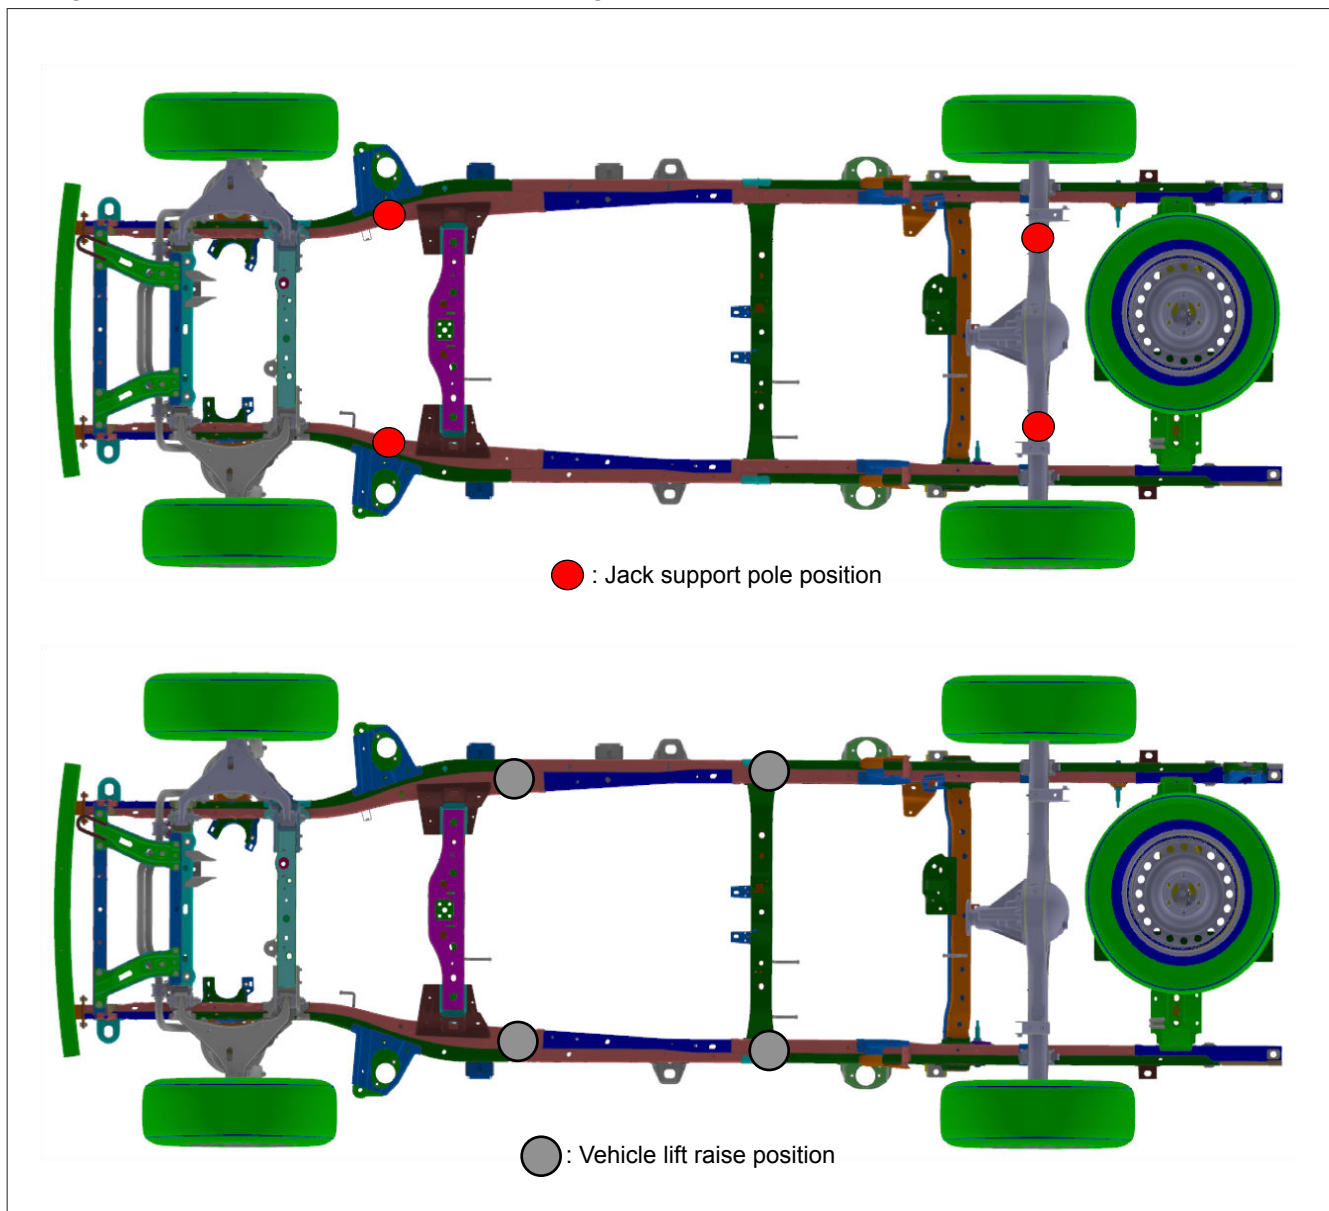
Lifting position of vehicle is as shown in the figure.

- › To avoid damages of the vehicle chassis or inclination of the vehicle, support the vehicle only at the specified supporting positions.
- › When performing the work under the vehicle, you must use proper bracket to support the vehicle in a secure manner.
- › After the vehicle is lifted, do not start the engine or put into gear if drive wheels are still on the ground.

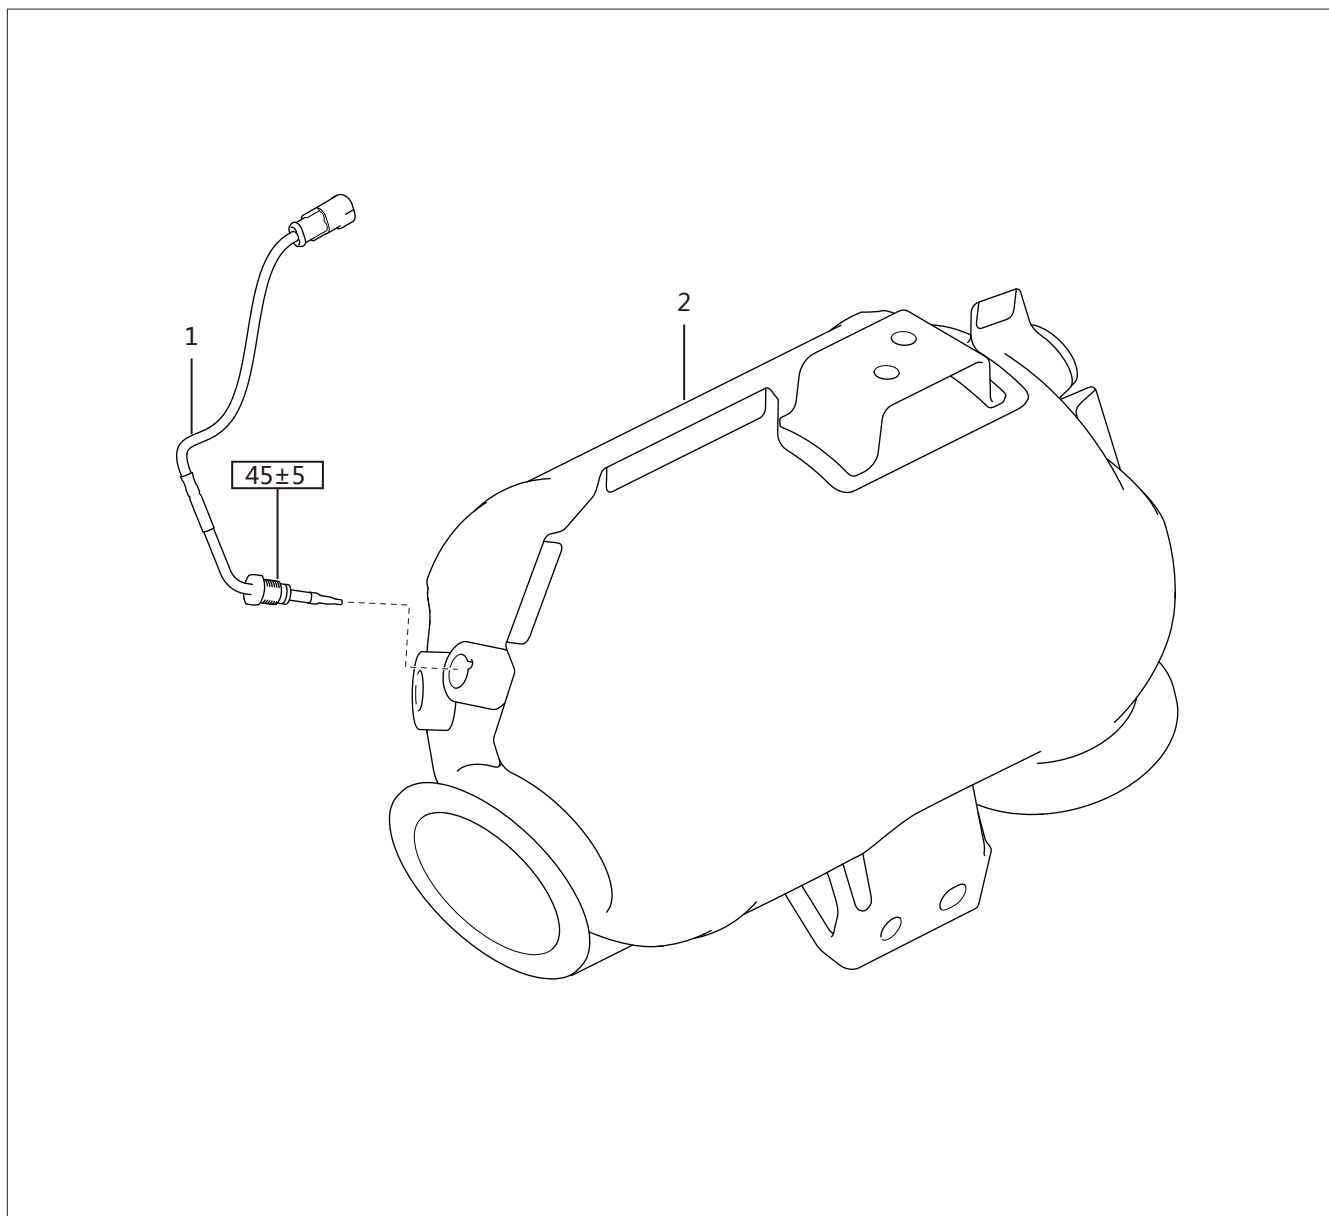
7143D22D2161

Structural diagram

1. DPF front high-temperature sensor

2. Particulate filter

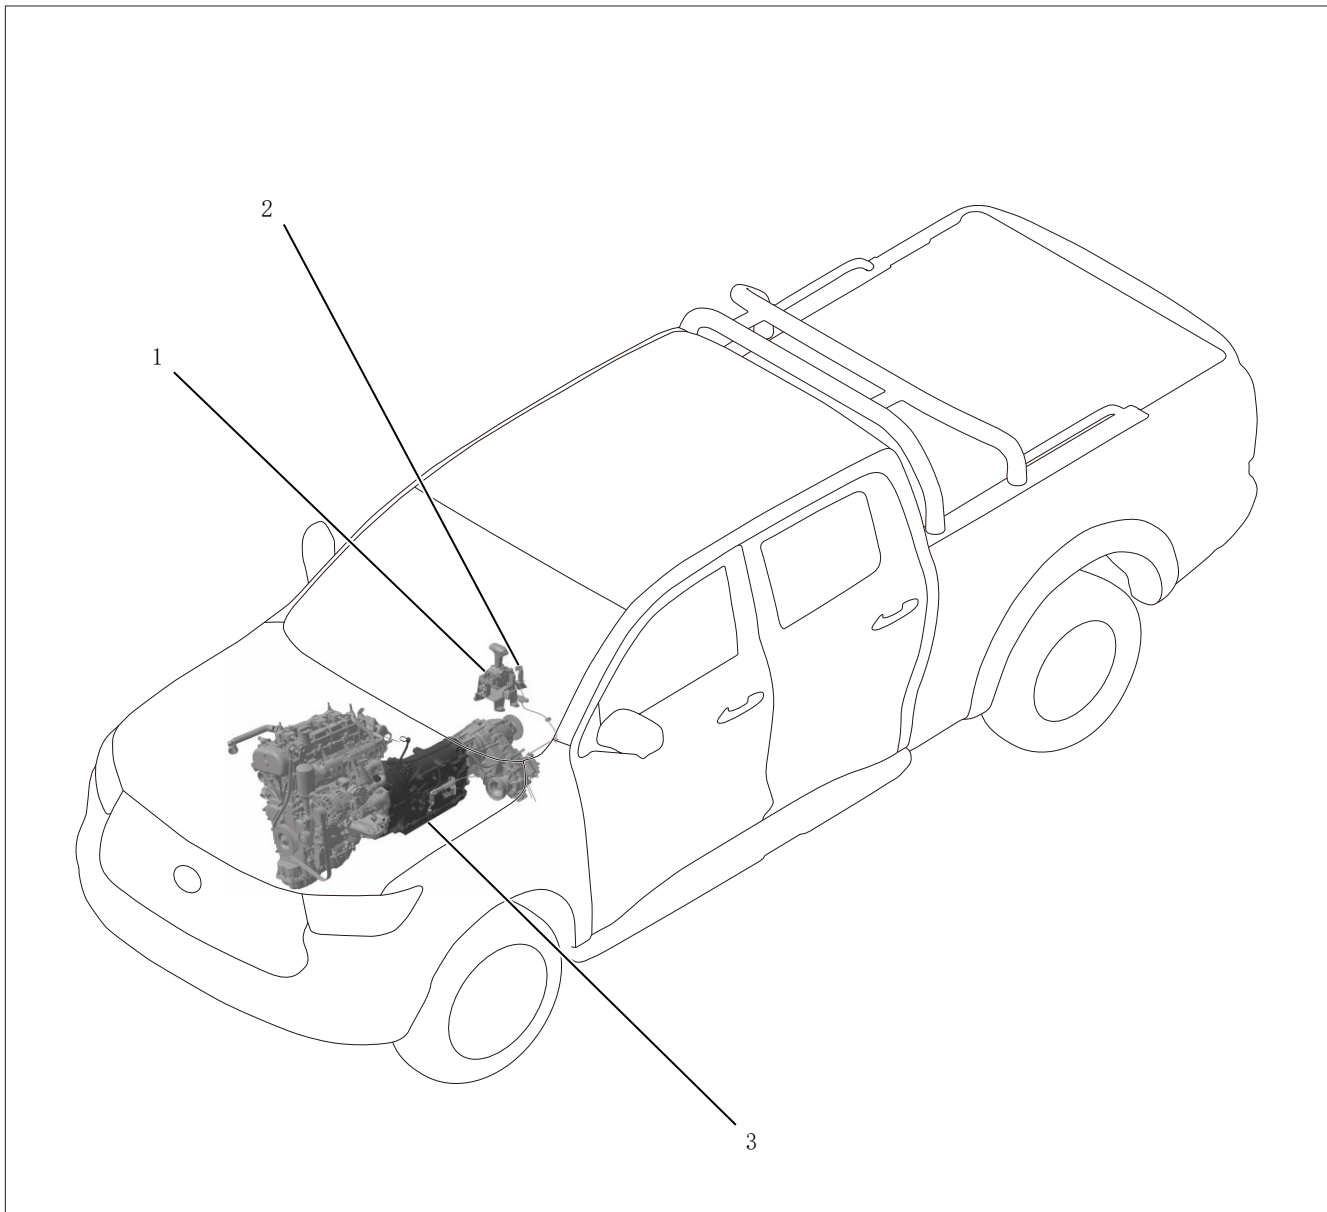
6AC47FDFAA73

Location diagram

1. Shifter assembly
2. P gear unlock cable

3. Automatic transmission assembly

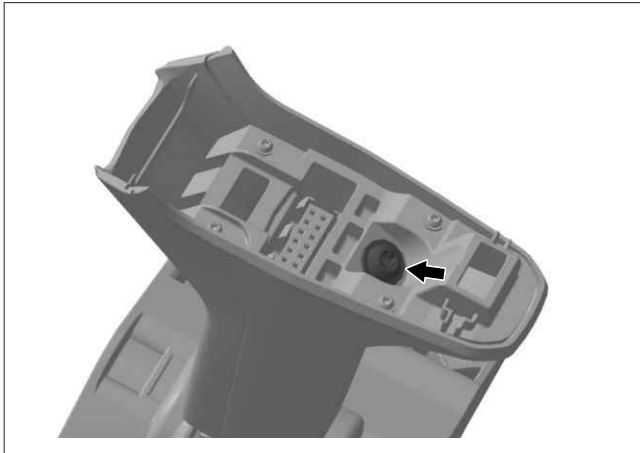
1A62F8E92910

4. Remove 1 gear shift lever mounting bolt

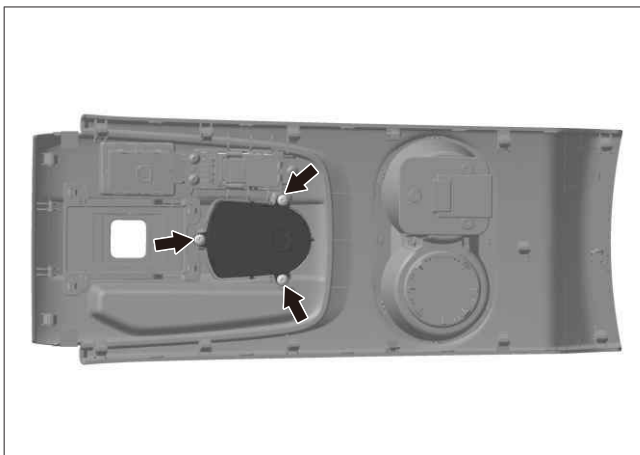
04536B04B96D

9. Remove the 3 screws

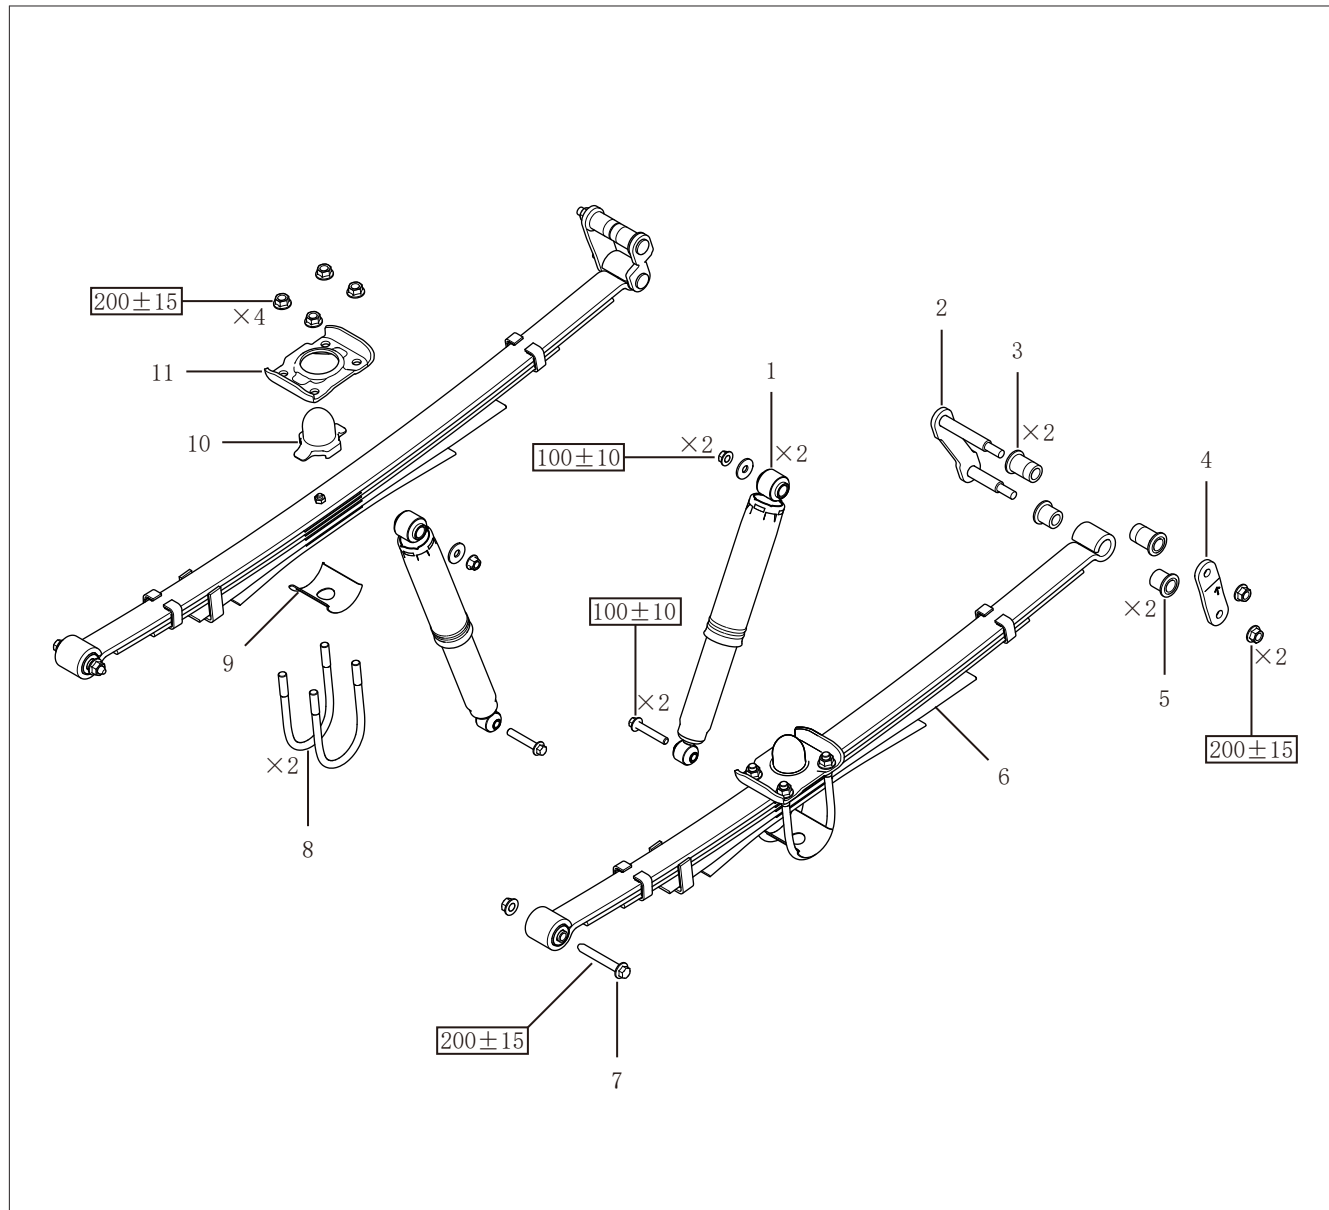
32A4552DF6C3

Structural diagram

| 1. Rear shock absorber assembly | 7. Front pin shaft of steel plate spring |
| 2. Rear lifting lug assembly of steel plate spring | 8. U-bolt |
| 3. Bush for steel plate spring | 9. U-bolt guard plate |
| 4. Rear lifting lug guard of steel plate spring | 10. Bumper block of rear suspension |
| 5. Bush for steel plate spring | 11. Bearing bush assembly |
| 6. Rear steel plate spring assembly | |

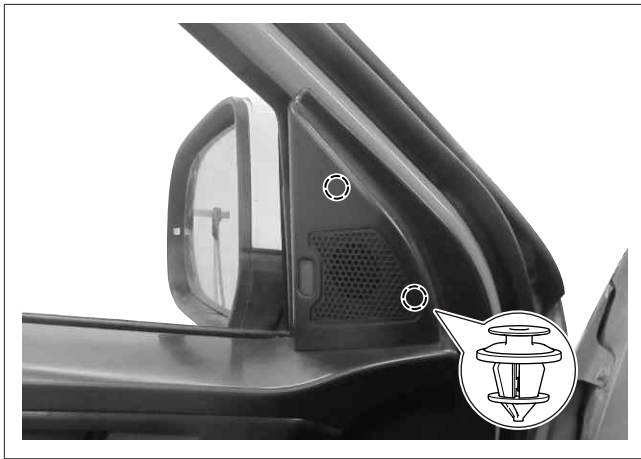
6355617693C4

1. Disconnect the negative terminal of the battery.
2. Separate 2 snaps, and remove front door interior triangle plate

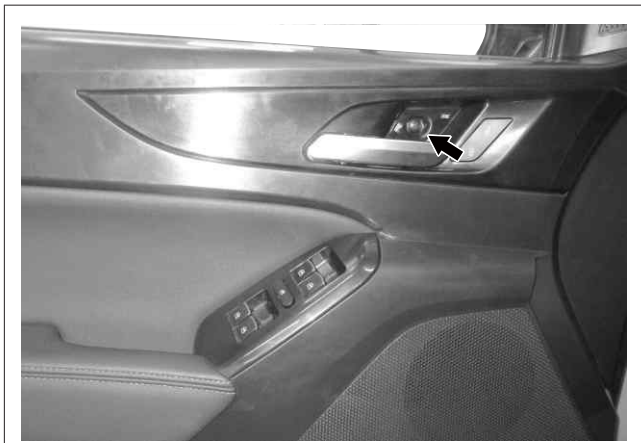
8EBC5BA4F9FC

3. Remove screw cover plate of front door interior handle
4. Remove 1 fastening screw on front door interior handle

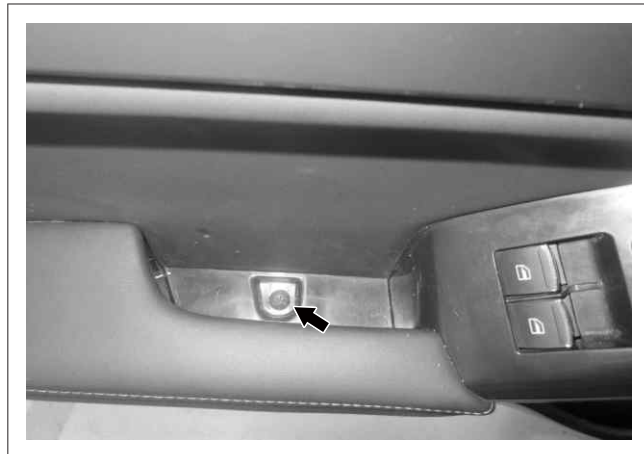
DD0E5EE2FDAC

6. Remove 1 fastening screw on front door handle box

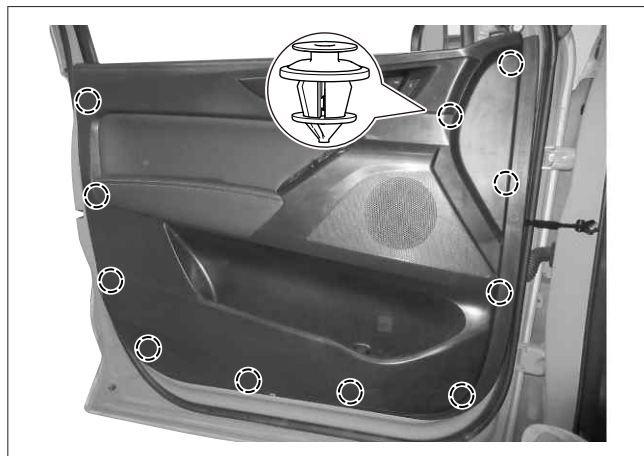
A4CF41F13A69

7. Separate 11 snaps

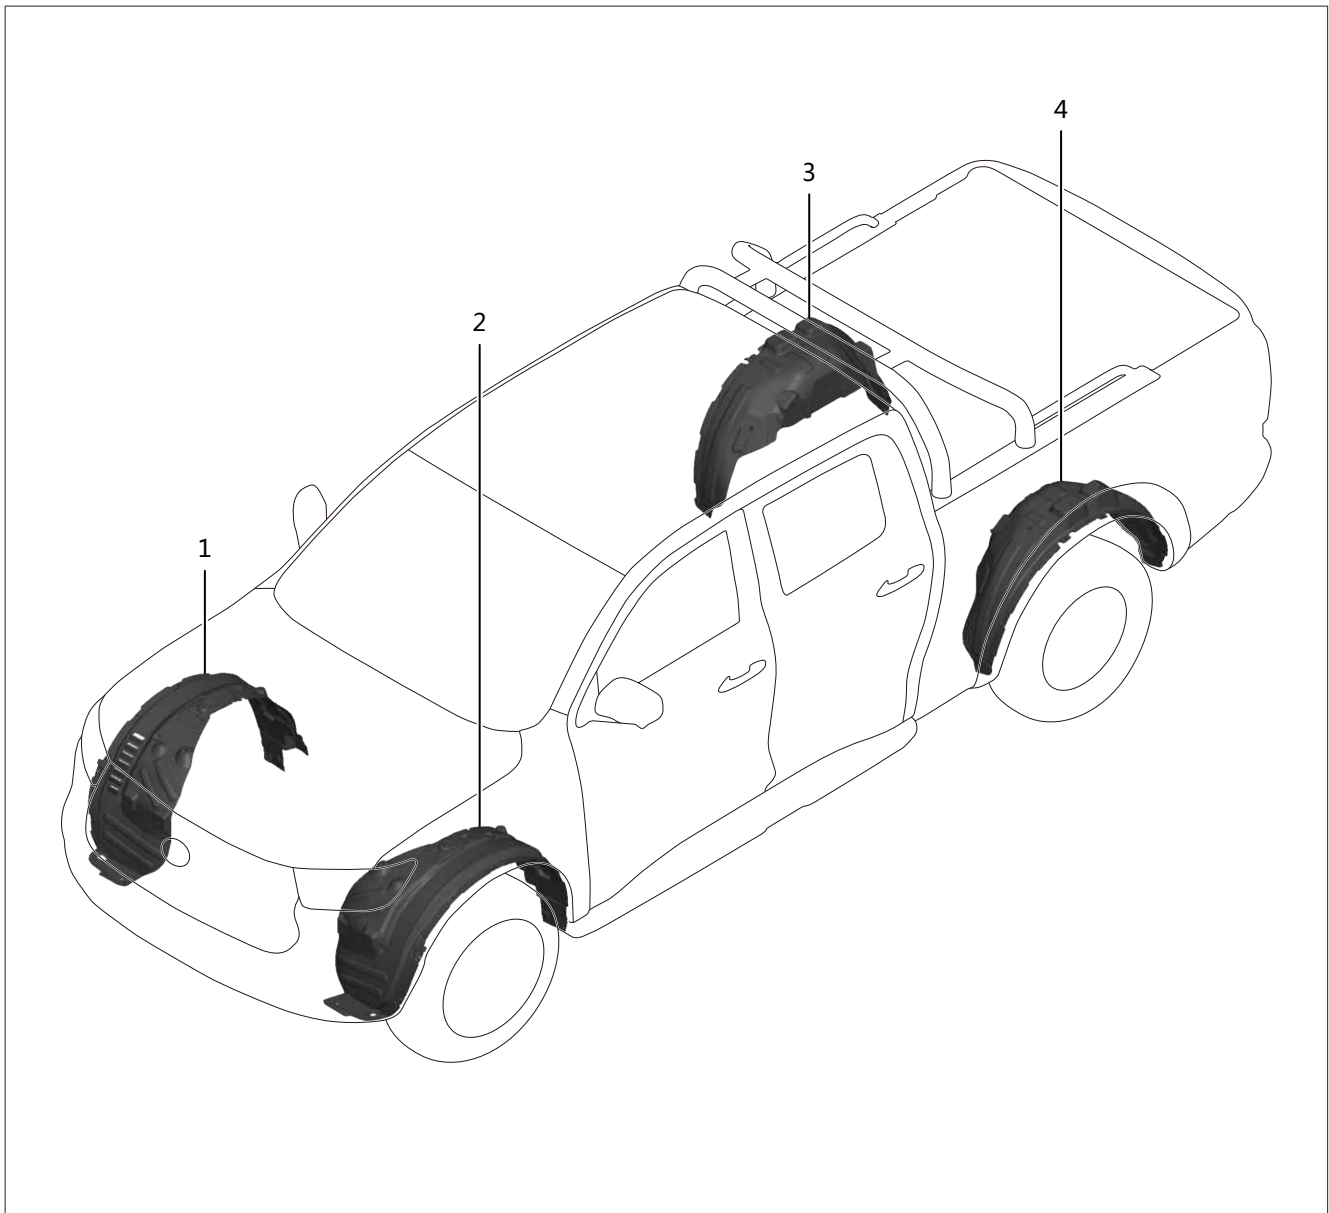
A8D0DD1BE3CD

Location diagram

1. Front right splash guard
2. Front left splash guard
3. Rear right splash guard
4. Rear left splash guard

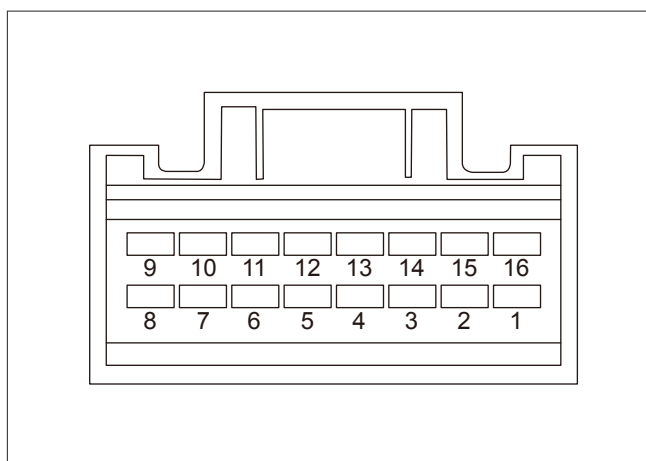
814C6DD52E80

Pin definition

Pin No.	Function
1	GND
2	Power supply
3	—
4	—
5	—
6	—
7	—
8	—
9	Gated input
10	—
11	—
12	—
13	—
14	—
15	—
16	—

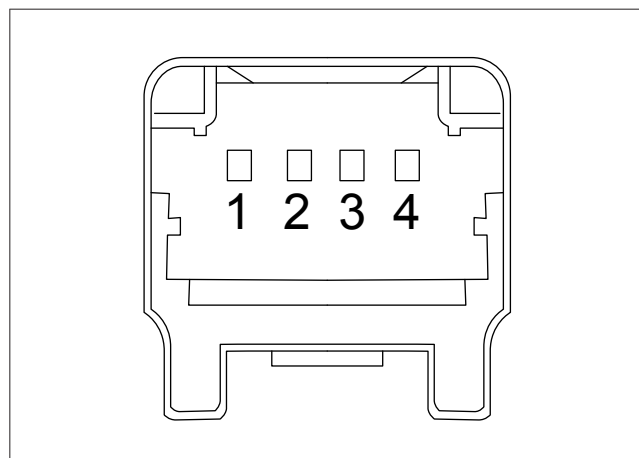
2B3078BF95EA

Pin No.	Function
1	Microphone power supply
2	Microphone GND
3	—
4	—
