### Central Locking System - 172 Chassis

### CENTRAL LOCKING, CONVENIENCE FEATURE, DRIVE AUTHORIZATION SYSTEM - AH80.00-Z-9999AZ

### OVERVIEW OF SYSTEM COMPONENTS FOR THEFT PROTECTION AND LOCKING - GF80.00-P-9999RD

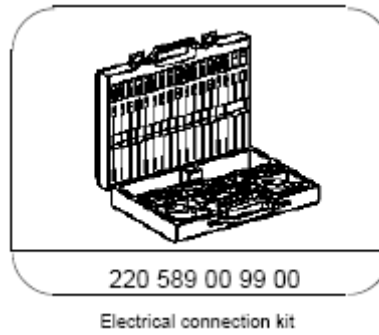
**Fig. 12: Identifying Electrical Connection Kit (220 589 00 99 00)**  
Courtesy of MERCEDES-BENZ USA

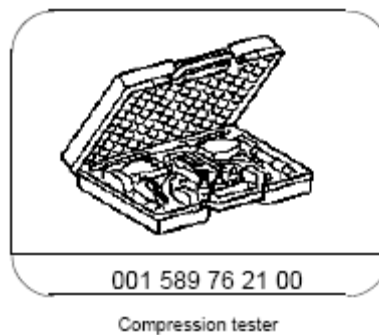
**Fig. 13: Identifying Compression Tester (001 589 76 21 00)**  
Courtesy of MERCEDES-BENZ USA

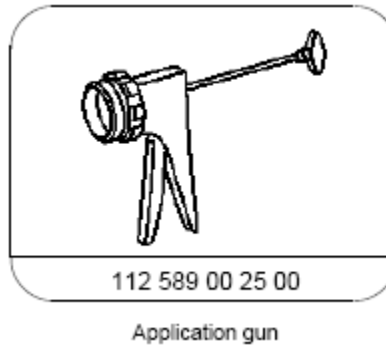
**Fig. 109: Identifying Application Gun (112 589 00 25 00)**

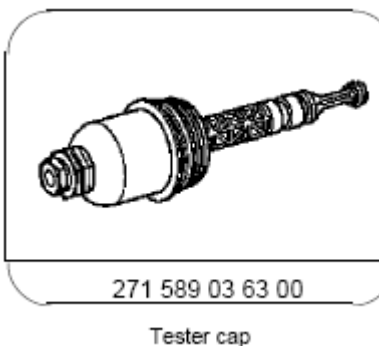
**Fig. 4: Identifying Tester Cap (271 589 03 63 00)**
