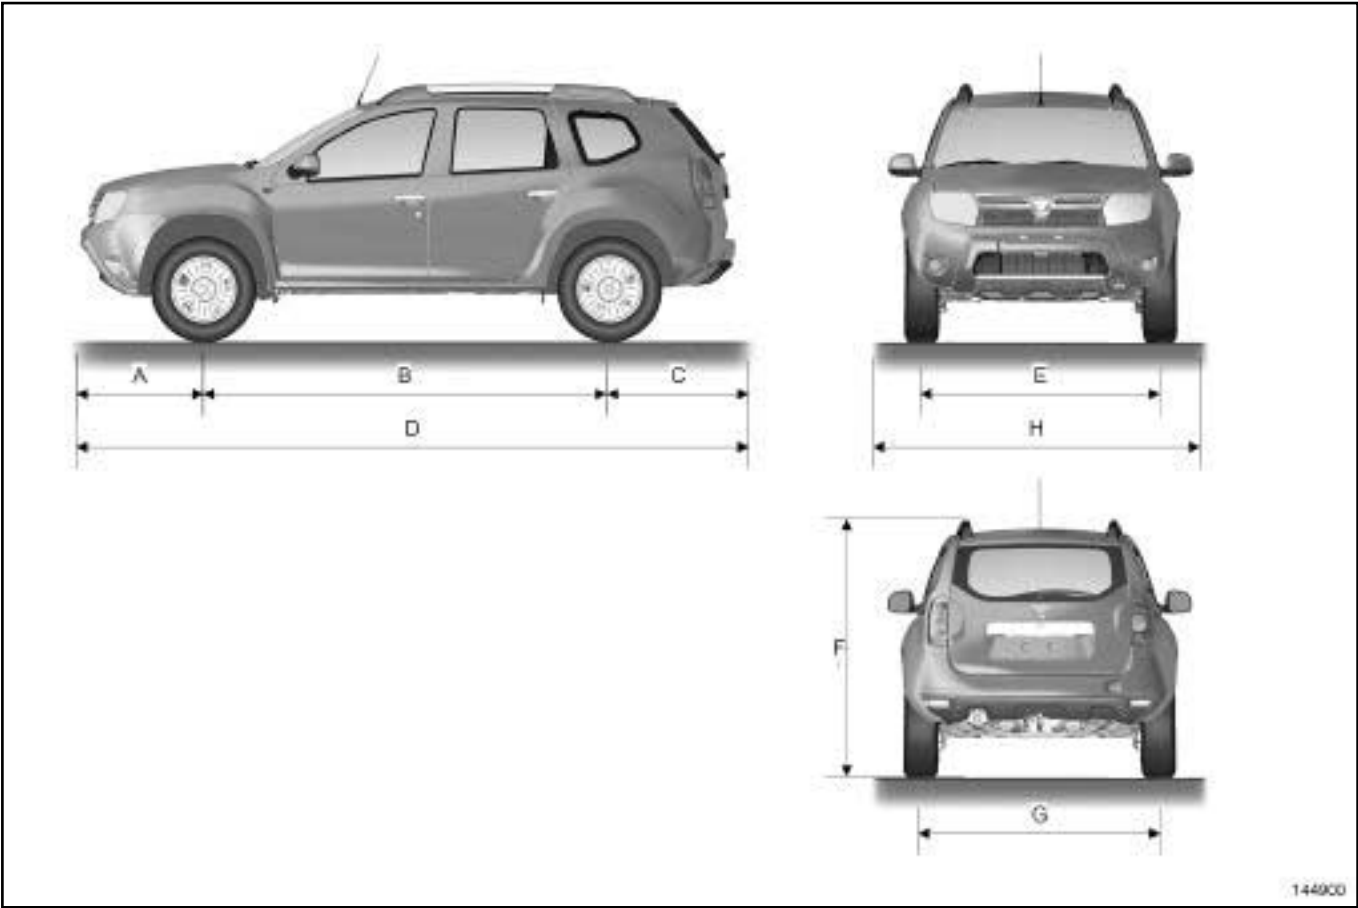
144900

4X2 TRANSMISSION

Dimensions in metres:

(A)	0.822
(B)	2.673
(C)	0.820
(D)	4.315
(E)	1.560
(F) (unladen)	1.690
(G)	1.567
(H)	1.822

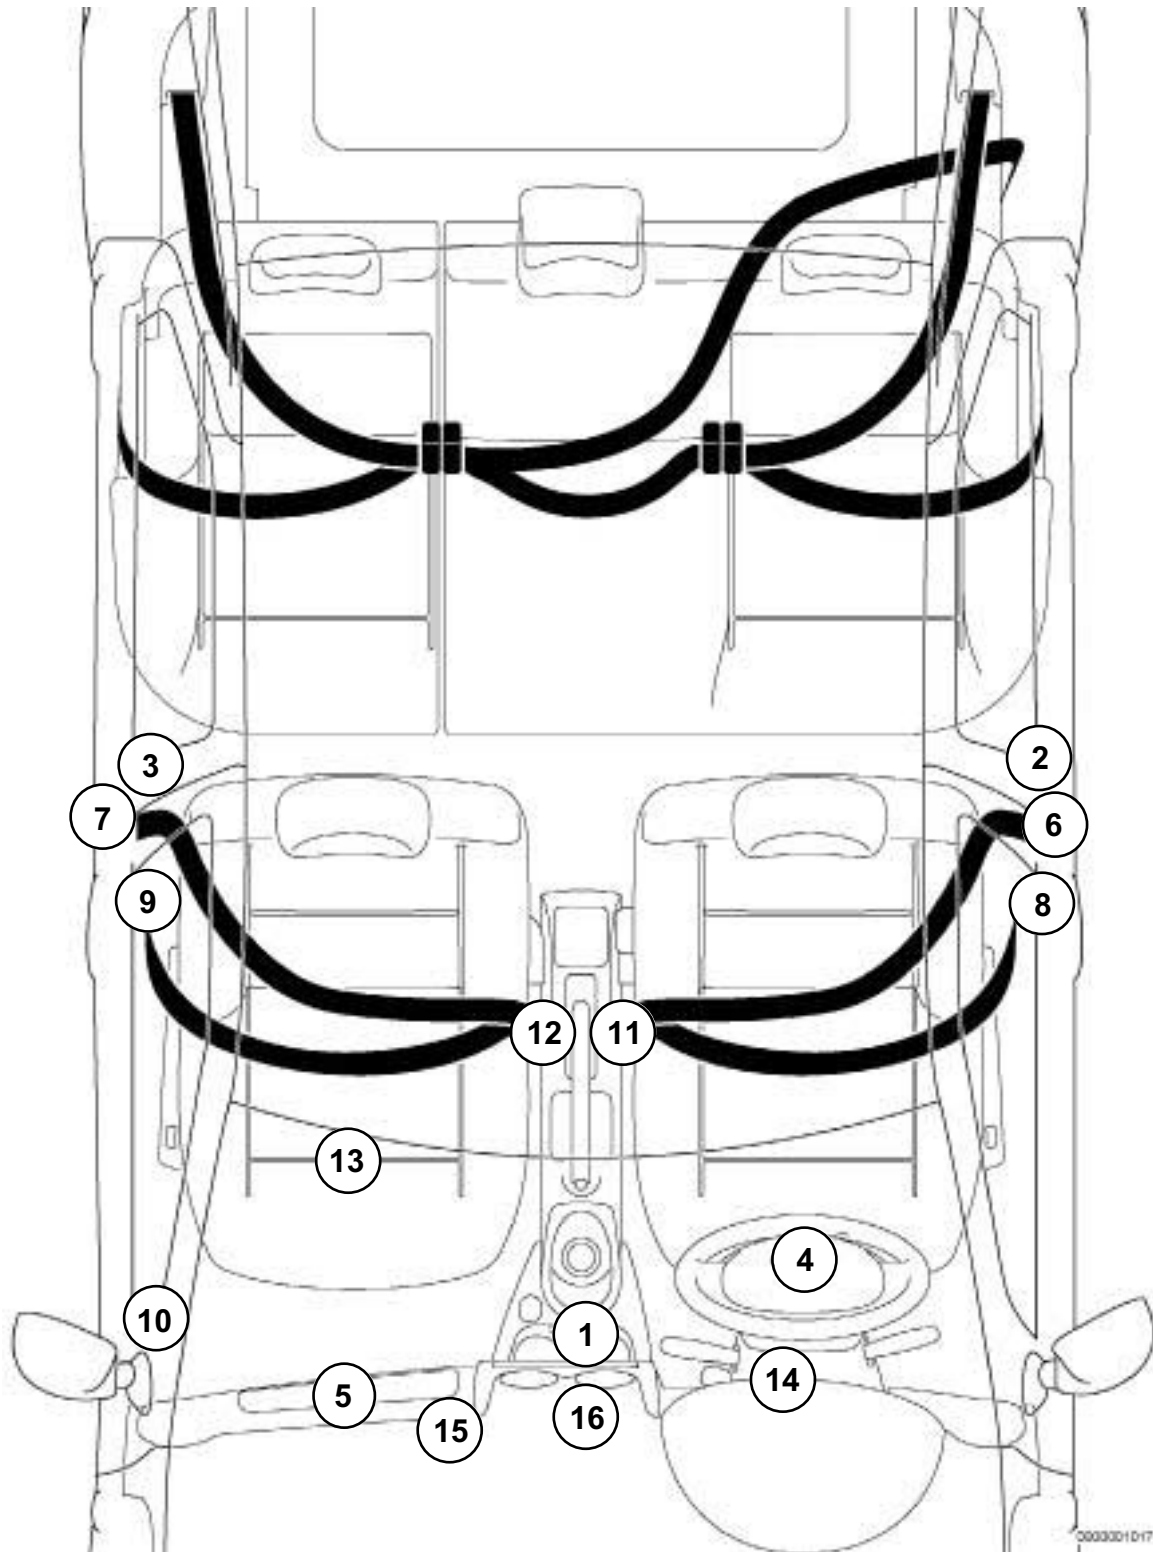
Passive Safety Architecture – Computer with 6 trigger lines.
