Technical Service Information

FORD AODE NO UPSHIFT

FORD AOD-E OUTPUT SHAFT RING GEAR SUPPORT AND REAR CASE BEARING IDENTIFICATION

FORD 4R70W 3-NEUTRAL SHIFT AND FORWARD CLUTCHES BURNT

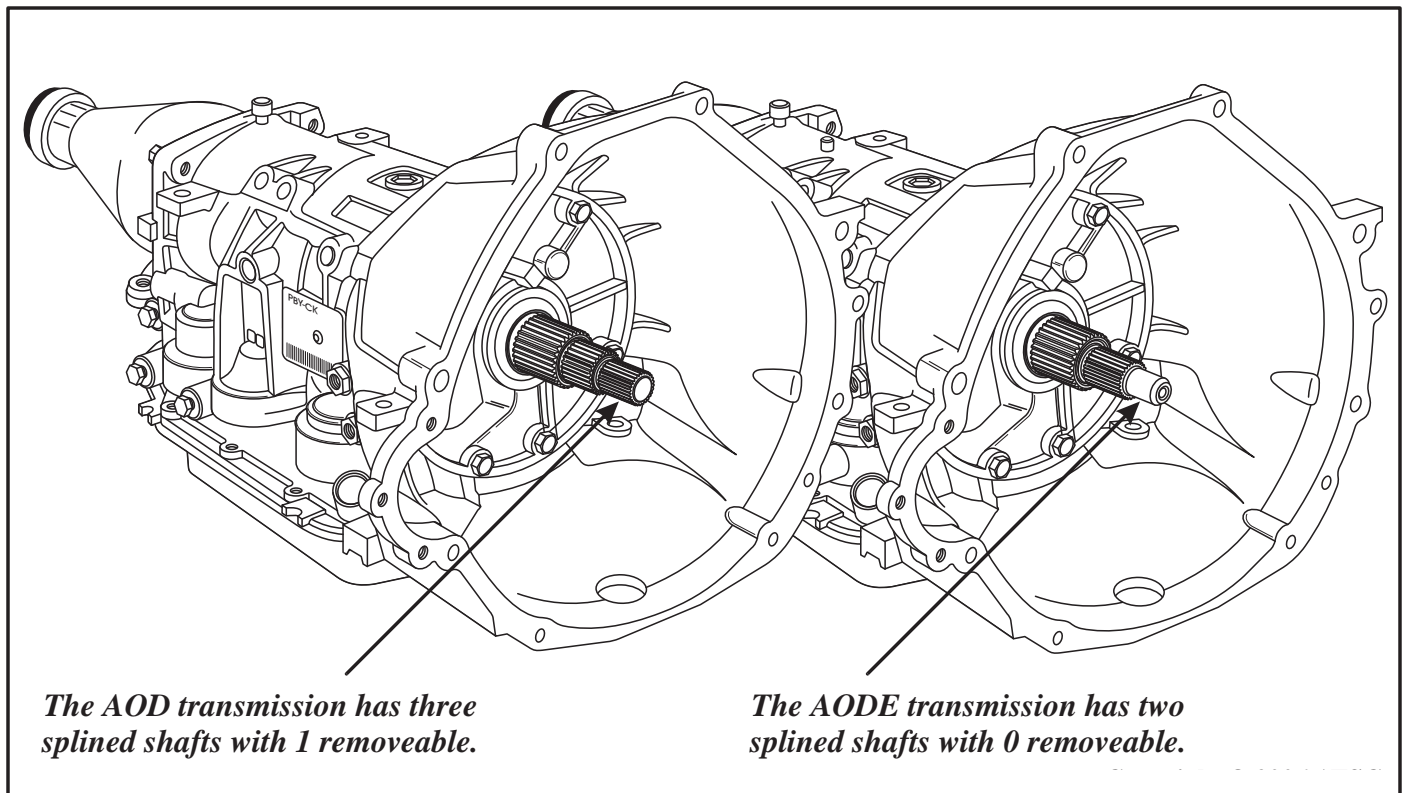
Figure 1

In its general appearance, the AODE transmission very closely resembles the hydraulically controlled AOD unit. However, the AODE is equipped with two splined shafts at the front of the unit, where the AOD is equipped with three, as shown in Figure 1. This would be a quick way to identify these units.

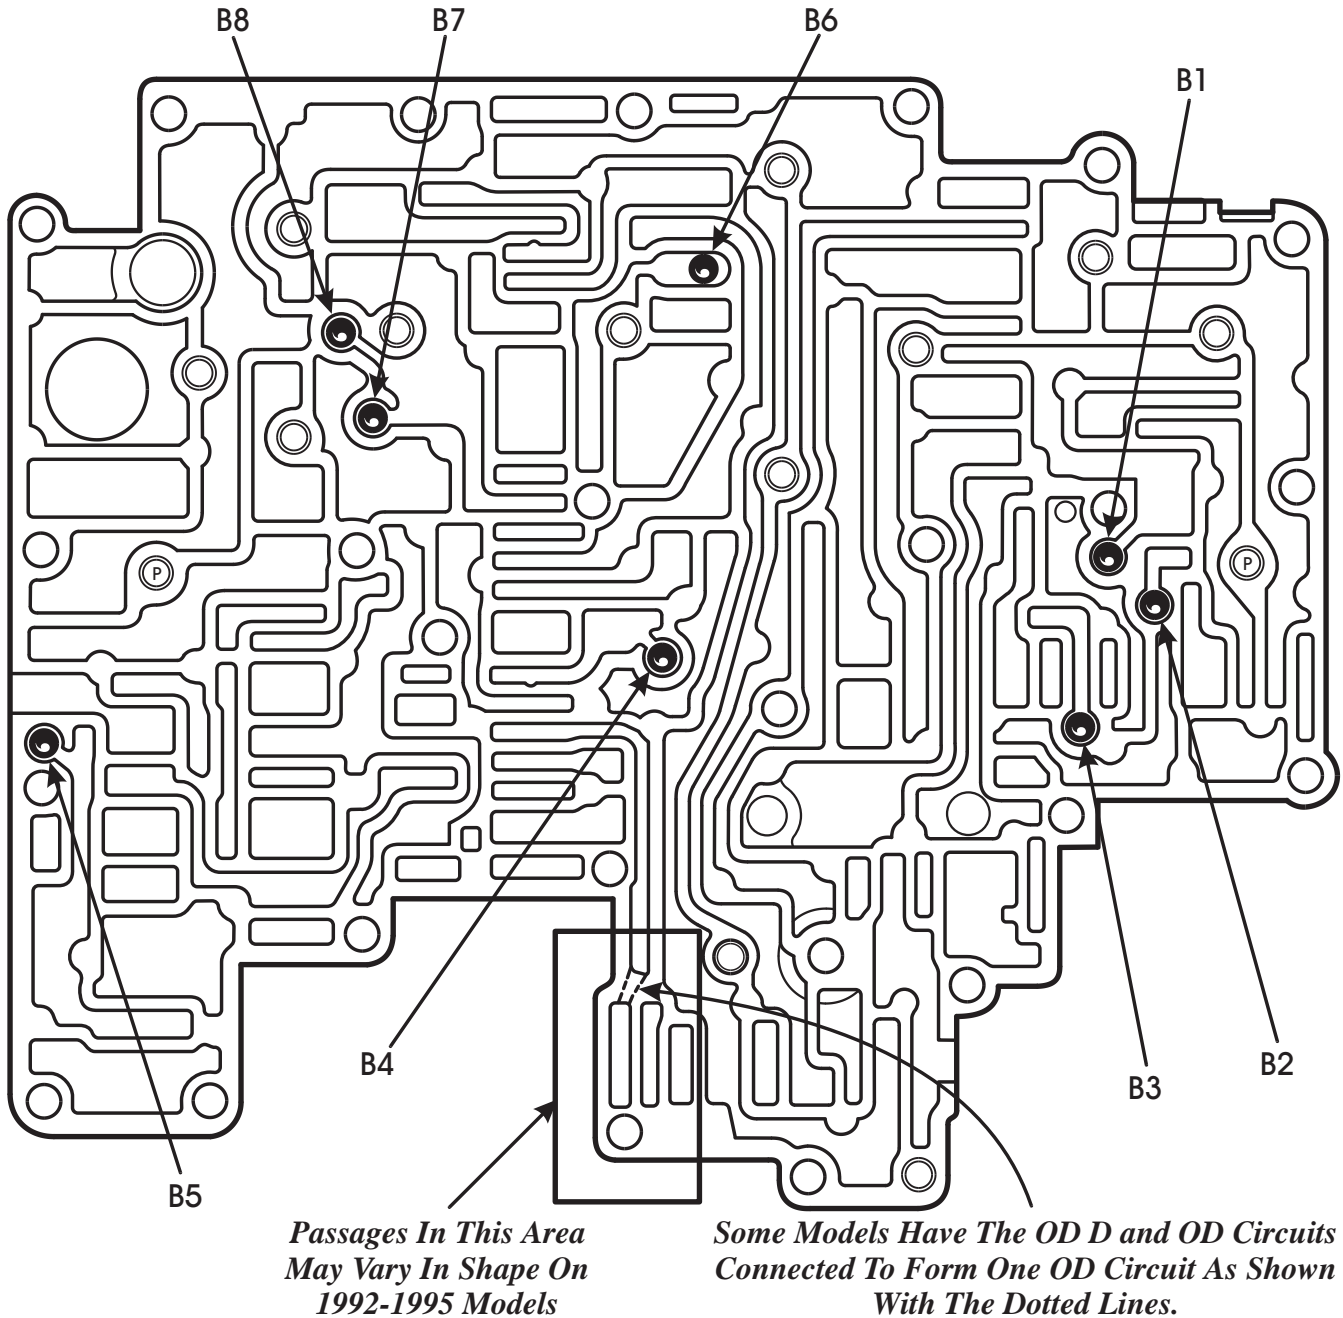
Figure 34

1992-1995 AODE/4R70W CHECKBALL LOCATIONS

- B1 - Between the Forward Clutch circuit and the 23BP circuit (92-95 Only).
- B2 - In the Forward Clutch circuit near the 3-4 shift valve.
- B3 - In the Direct Clutch circuit near the 2-3 backout valve.
- B4 - In the Overdrive and Forward Clutch circuits near the 1-2 shift valve.
- B5 - In the Reverse circuit near orifice number one.
- B6 - Shuttle ball between the Low and Reverse circuits.
- B7 - Between the L234 and Torque Converter Clutch circuits.
- B8 - Between the L234 and Intermediate Clutch circuits.

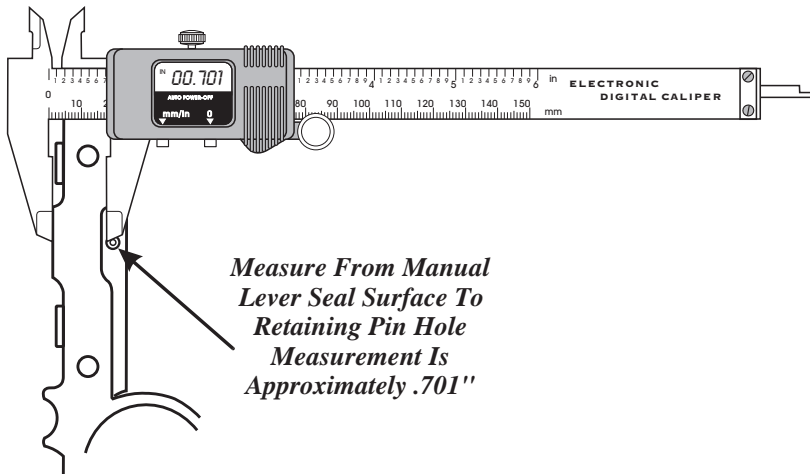
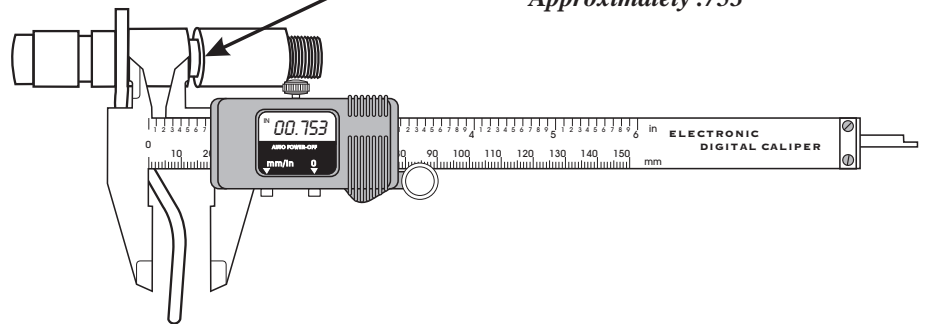
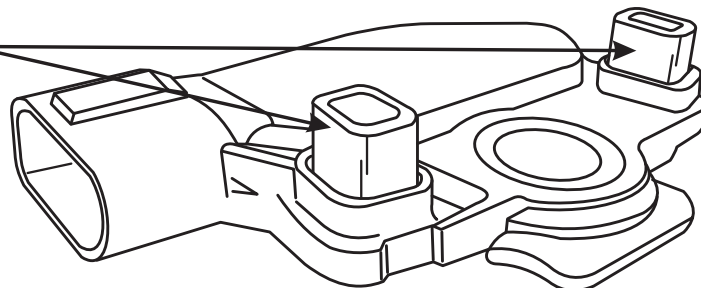
Figure 45

**TWO
DRILLED AND TAPPED
BOSSES IN THIS AREA**

*Measure From Manual
Lever Seal Surface To
Retaining Pin Hole
Measurement Is
Approximately .701"*

*Measure From Manual
Lever Surface To
Retaining Pin Groove
Measurement Is
Approximately .753"*

**MLPS HAS TALL
TORQUE LIMITERS**

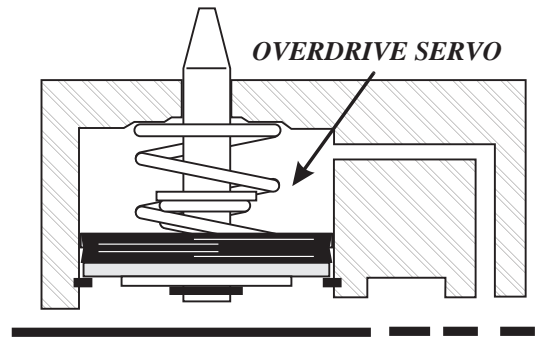
Figure 59

PREVIOUS DESIGN
CASE "WITH" .020" BLEED ORIFICE

2001 & UP DESIGN
CASE "WITHOUT" BLEED ORIFICE

OVERDRIVE SERVO
BORE

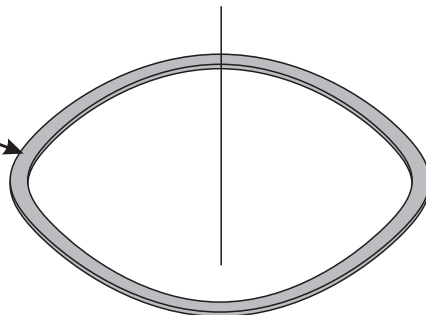
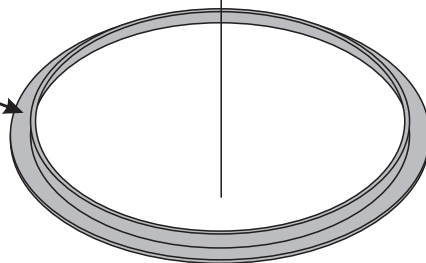
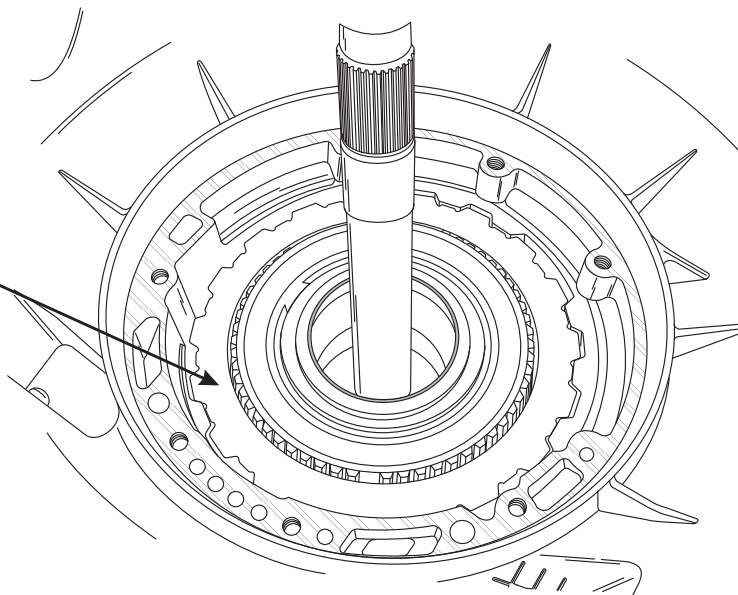
Figure 62

NEW DESIGN LEVEL RETURN SPRING AND INTERMEDIATE CLUTCH ASSEMBLY

Install "Waved" Return Spring

Install Return Spring Retainer

Intermediate Friction And Steel Plates Installed

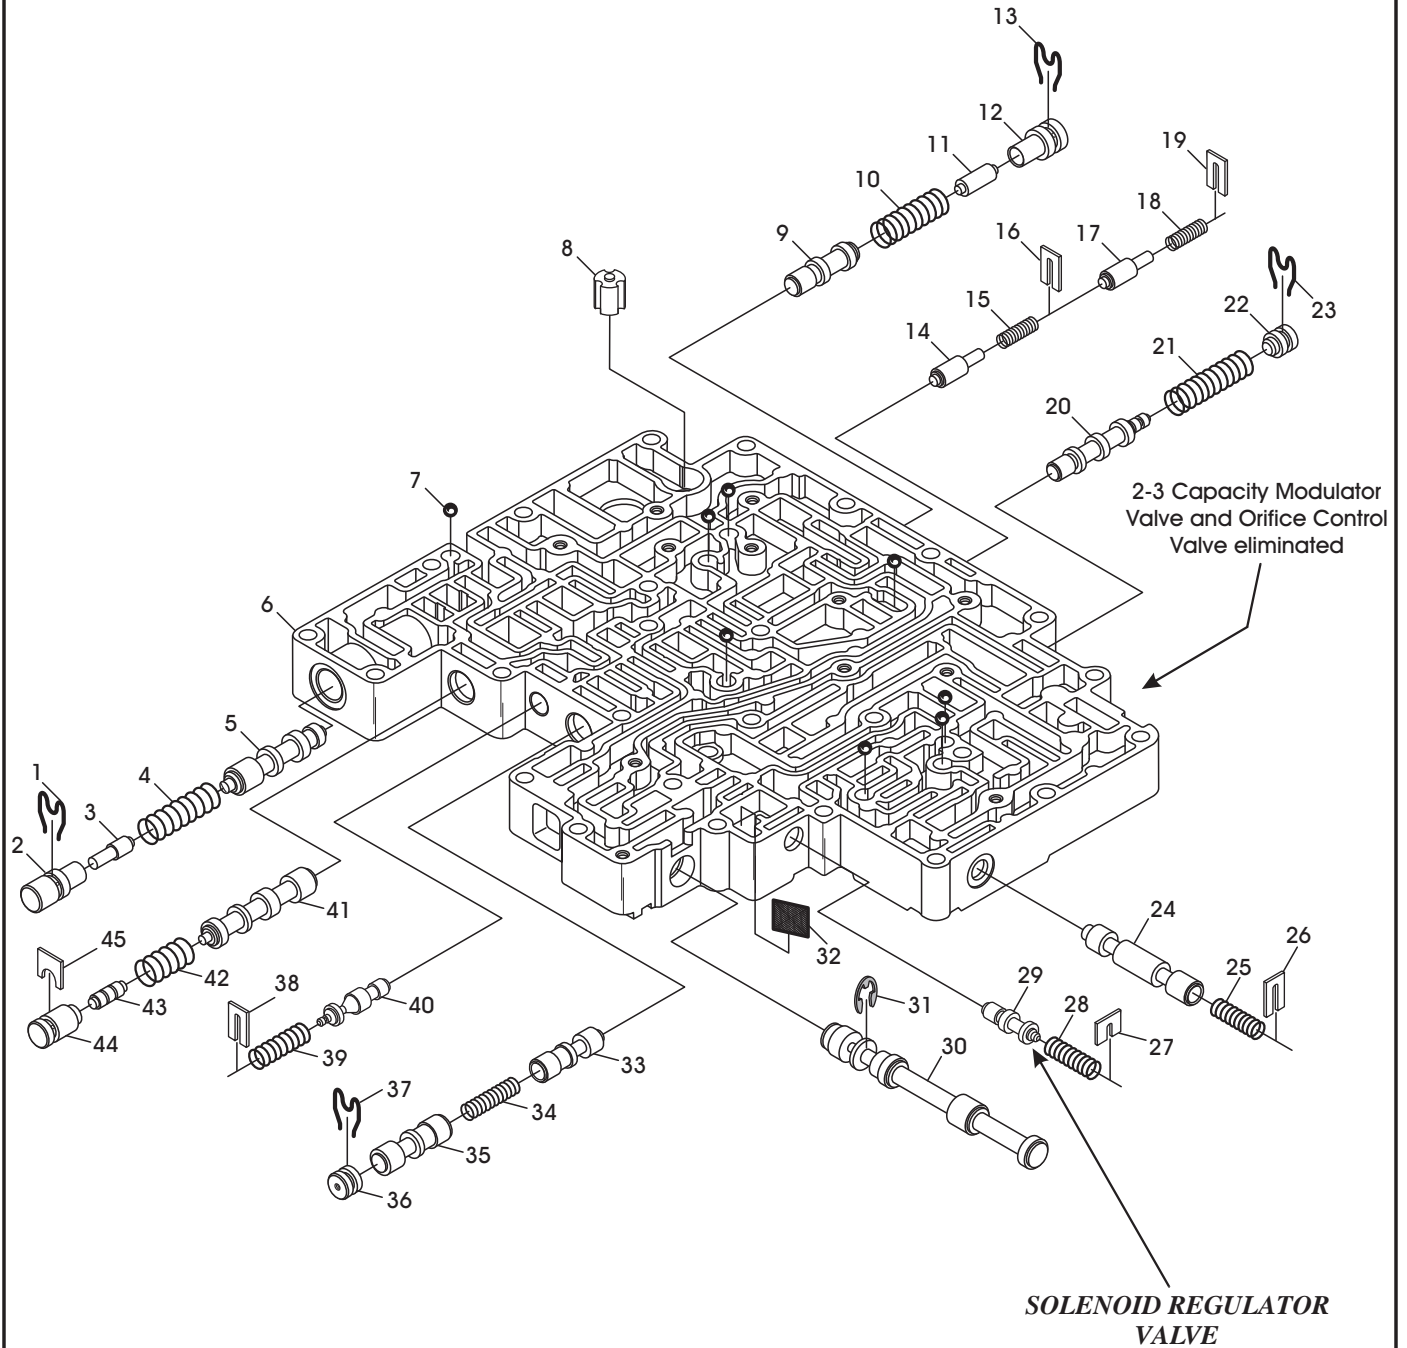
Figure 88

FORD 4R70W 2001-UP MAIN VALVE BODY EXPLODED VIEW

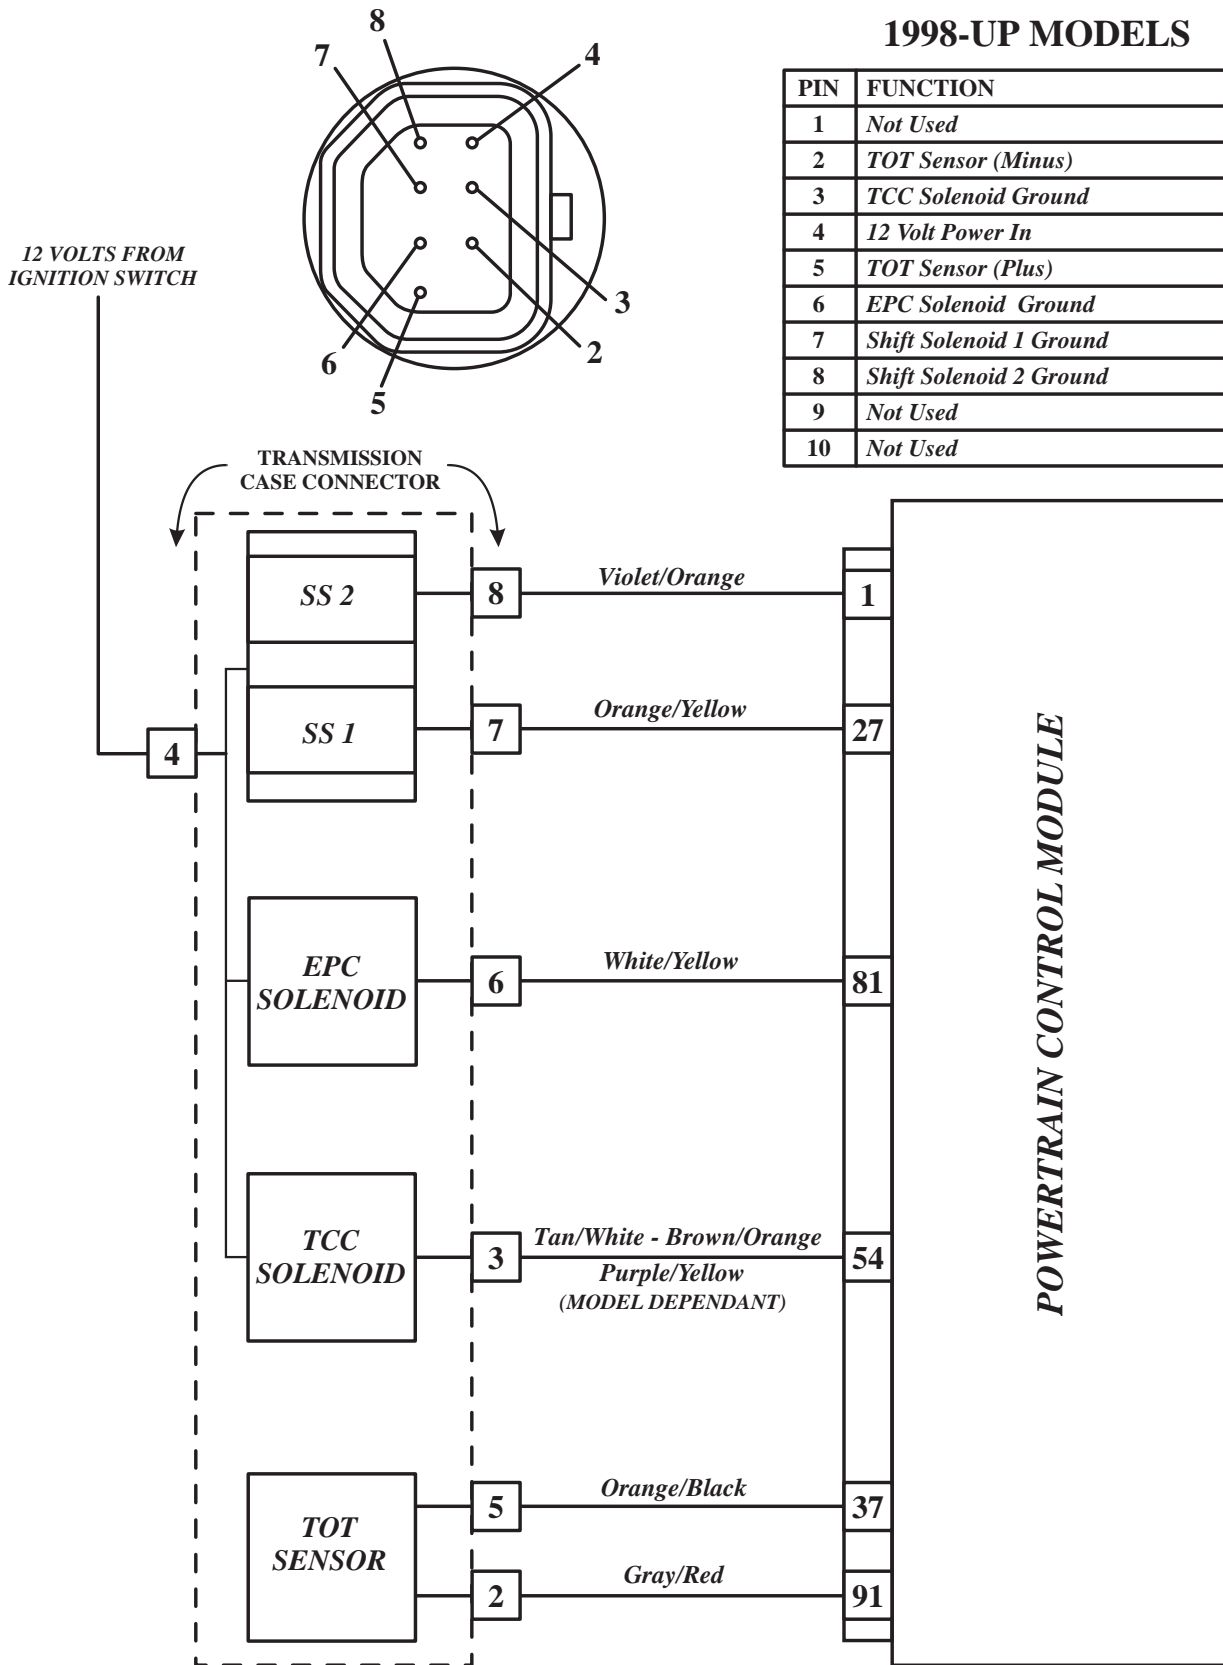
Figure 95

PIN	FUNCTION
1	Not Used
2	TOT Sensor (Minus)
3	TCC Solenoid Ground
4	12 Volt Power In
5	TOT Sensor (Plus)
6	EPC Solenoid Ground
7	Shift Solenoid 1 Ground
8	Shift Solenoid 2 Ground
9	Not Used
10	Not Used

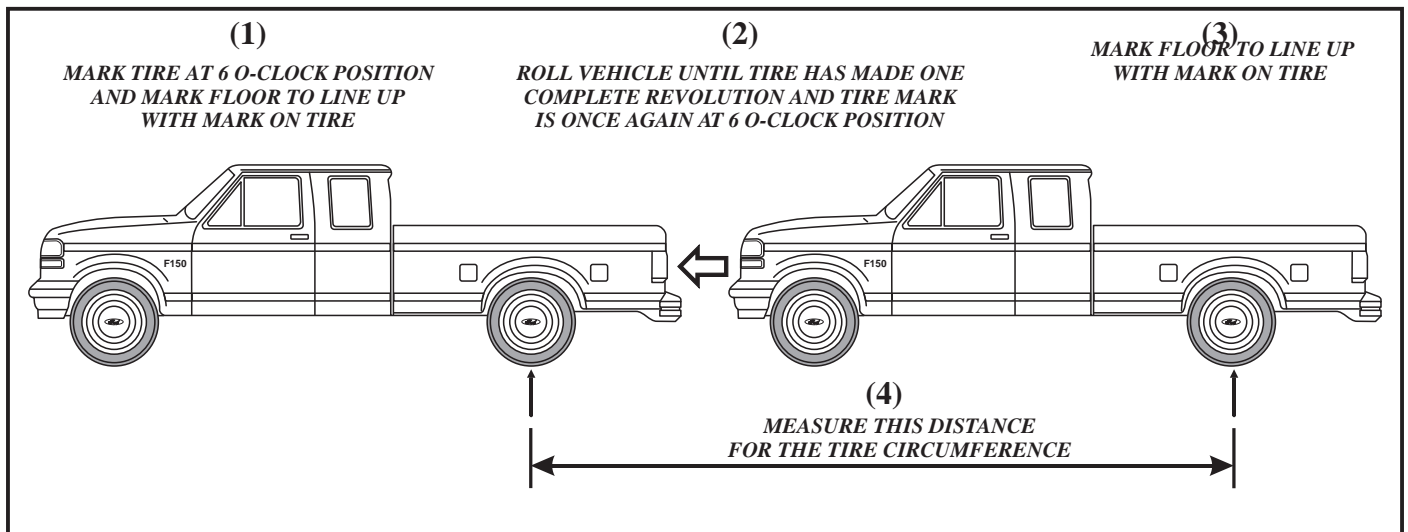
Figure 118

Formula 4 in Figures 117 and 118 are used when tire size or gear ratios are questionable.
