## A4LD UPDATE HANDBOOK INDEX

AUTOMATIC TRANSMISSION SERVICE GROUP  
9200 S. DADELAND BLVD. SUITE 720  
MIAMI, FLORIDA 33156  
(305) 670-4161

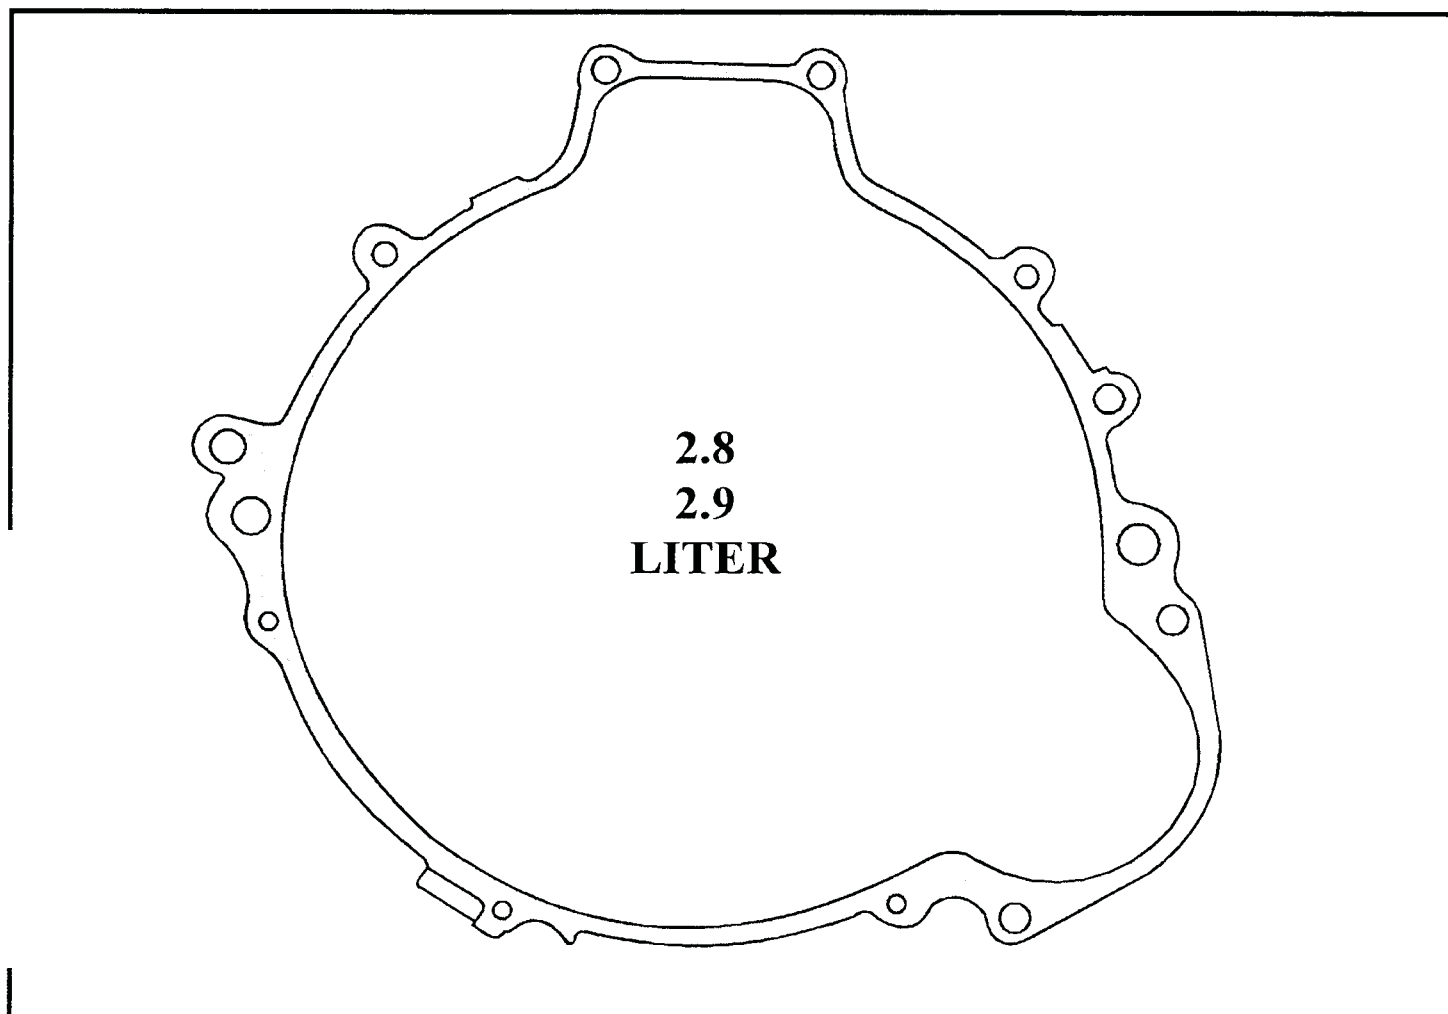
Figure 2

**A4LD BELL HOUSING IDENTIFICATION**

**2.8 LITER**

<b>1 SOLENOID</b>	<b>2 SOLENOIDS</b>	<b>MODEL</b>
1985 - 1987	N/A	2WD / 4WD RANGER
1985 - 1987	N/A	BRONCO II
1985 - 1987	N/A	AEROSTAR

**2.9 LITER**

<b>1 SOLENOID</b>	<b>2 SOLENOIDS</b>	<b>MODEL</b>
N/A	1988 - UP	2WD / 4WD RANGER
N/A	1988 - 1990	2WD / 4WD BRONCO II
1987 ONLY	1988 - 1990	MERKUR SCORPIO

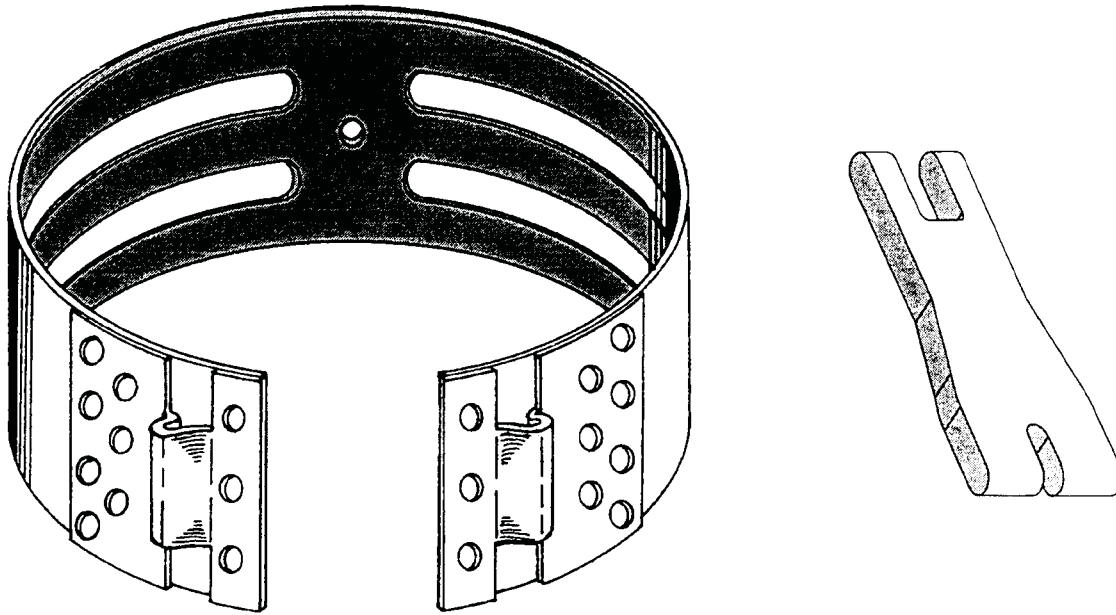
Figure 15

**PREVIOUS DESIGN BAND & STRUT  
BAND ADJUSTMENT= 2.0 TURNS**

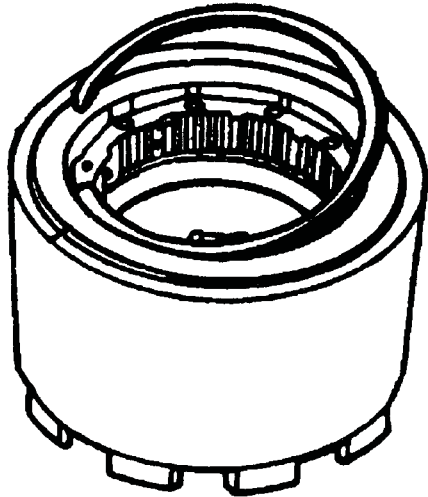
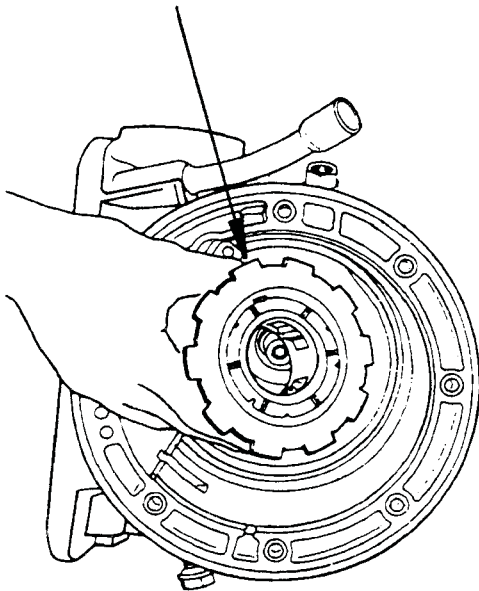
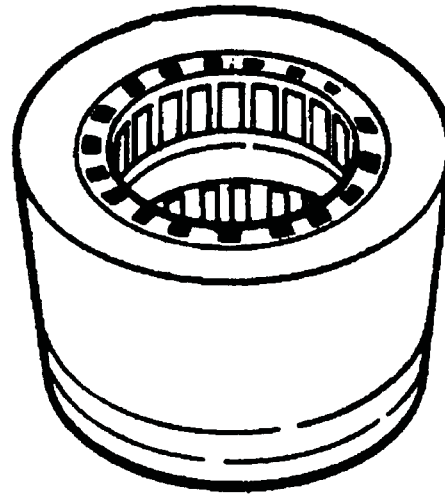
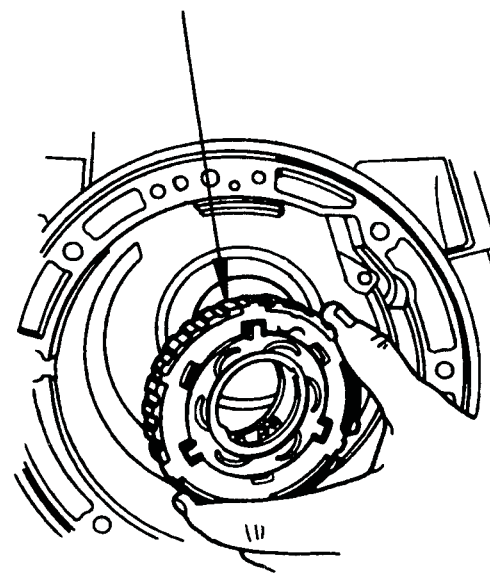
Figure 46

**"1ST DESIGN"  
REVERSE DRUM  
WITH ROLLER CLUTCH**

**REQUIRES THE "2ND DESIGN"  
10 LUG REAR CARRIER**

**"2ND DESIGN"  
REVERSE DRUM  
WITH SPRAG**

**REQUIRES THE "3RD DESIGN"  
MULTIPLE LUG REAR CARRIER**

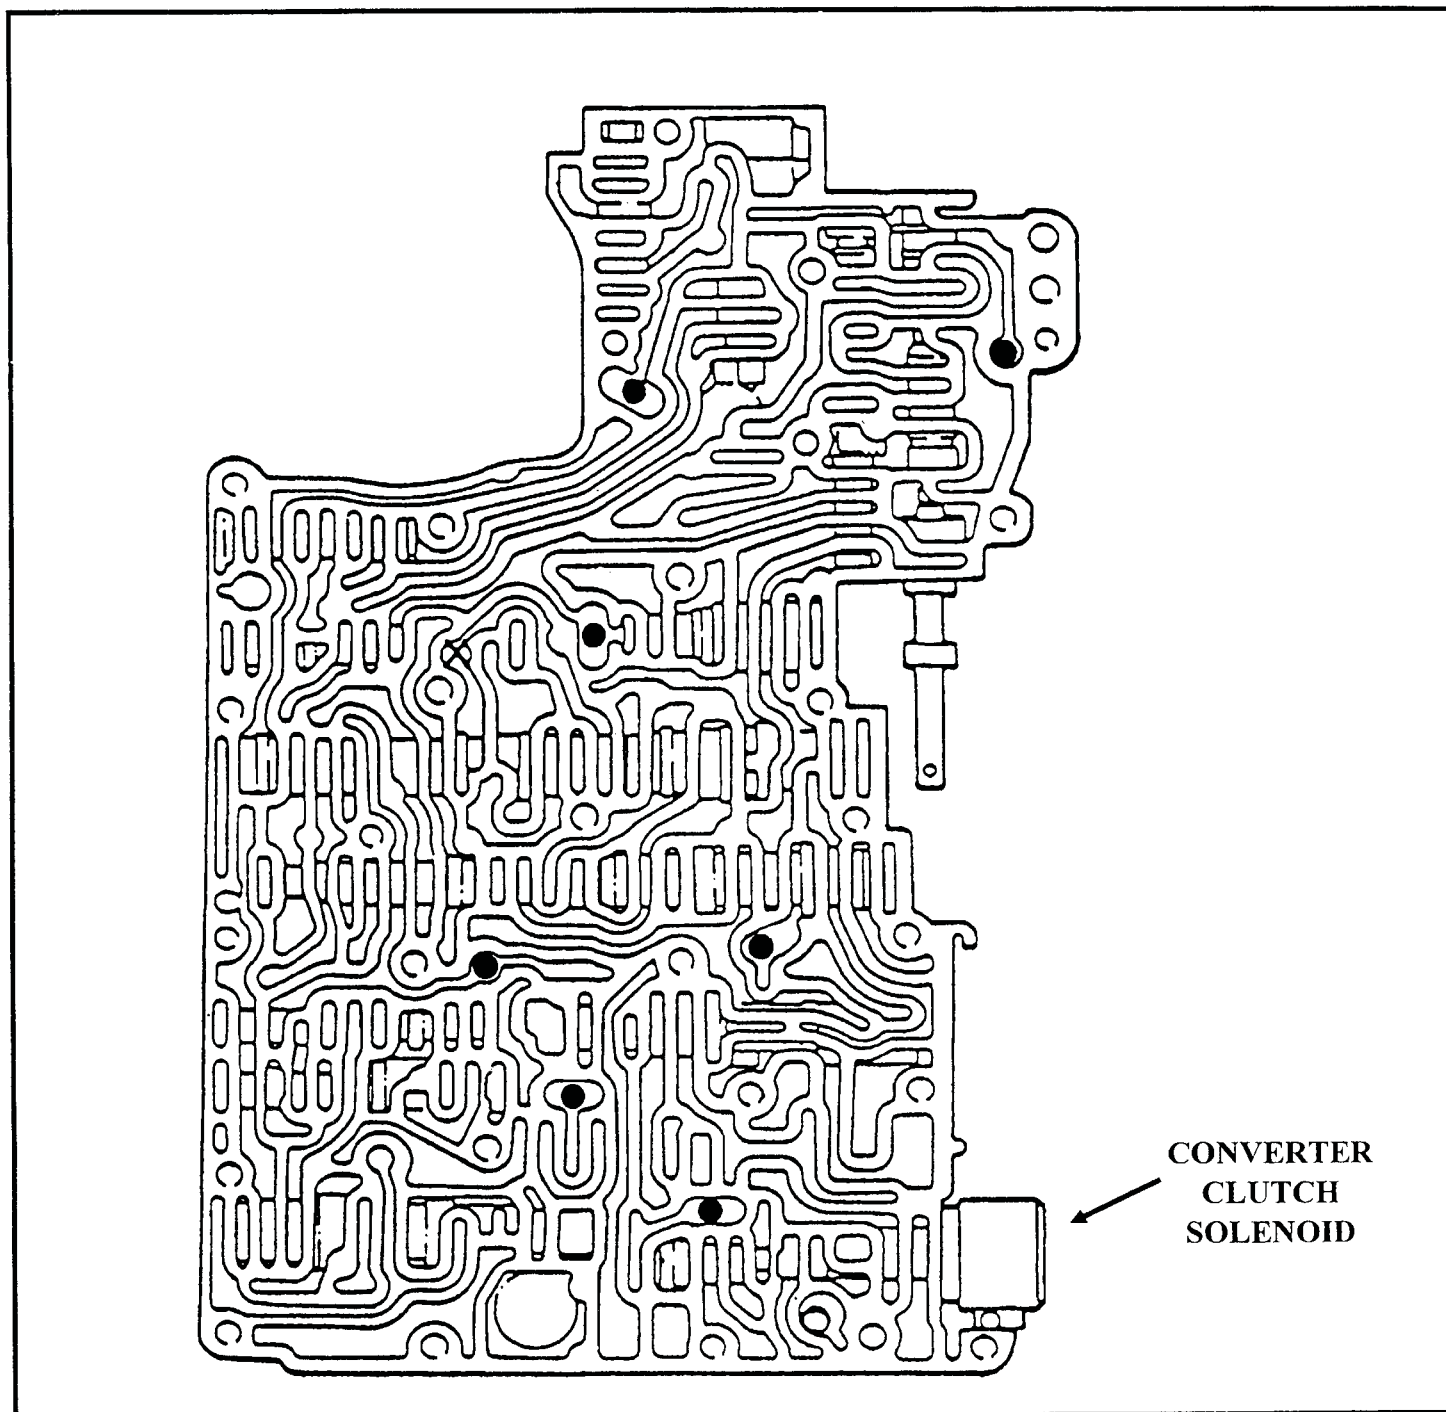
Figure 63

**CHECK BALL LOCATION  
SINGLE SOLENOID VALVE BODY  
SCORPIO / MERCUR ONLY**
