Front fender (➤ VIN 8D XA 200 000), assembly overview

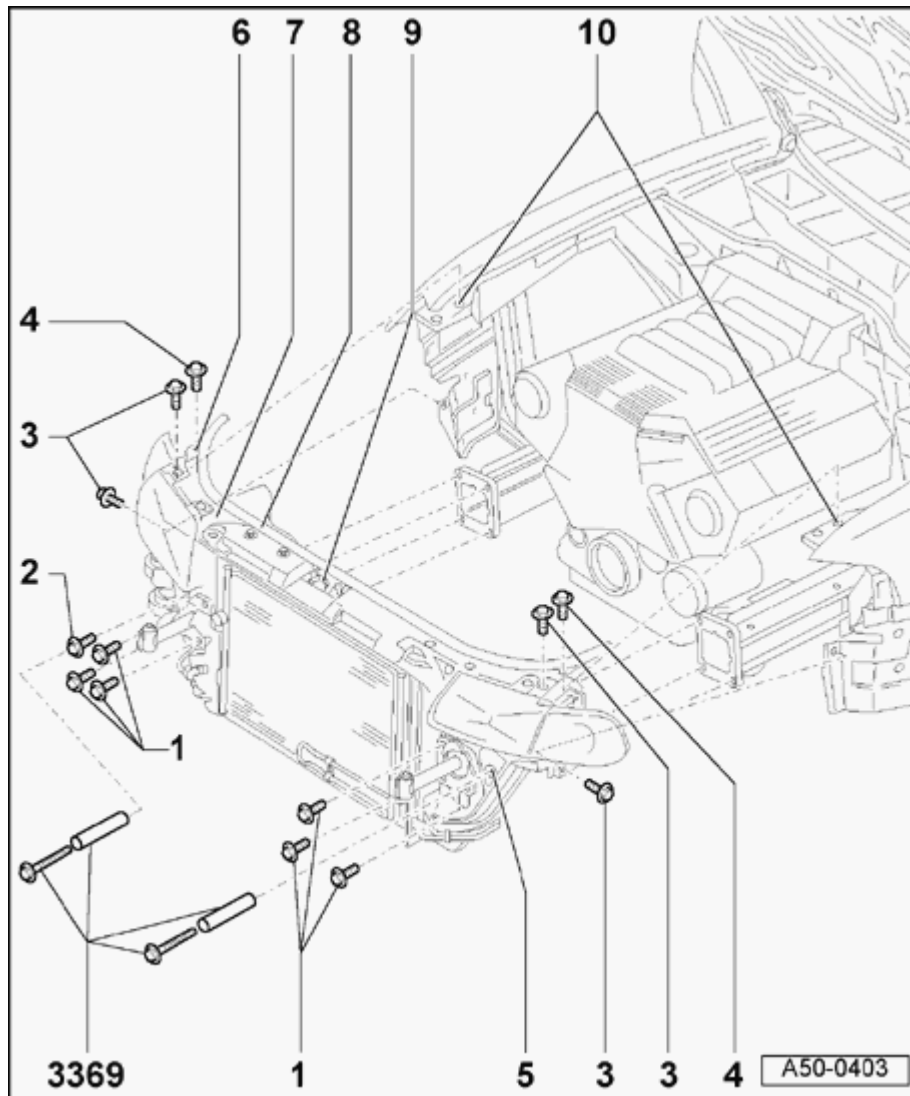
**Notes:**

- ◆ Do not suspend hydraulic fluid cooler by its lines.
- ◆ Hydraulic fluid cooler must not be bent or kinked under any circumstances
- ◆ On vehicles with automatic transmission, remove ATF cooler

- ◆ On vehicles with charge air cooler, remove intake air duct
 - Loosen seal for hood -8- at left and right where fender meets lock carrier -7-.
 - Remove bolts -3- and -4-.
- A second mechanic is needed to support lock carrier -7-
 - Remove bolts -1- and -2-.
