**2019.0 E-PACE (X540), 303-00**

## **Engine System - General Information**

# **Cylinder Bore Out-of-Round** (G61243)

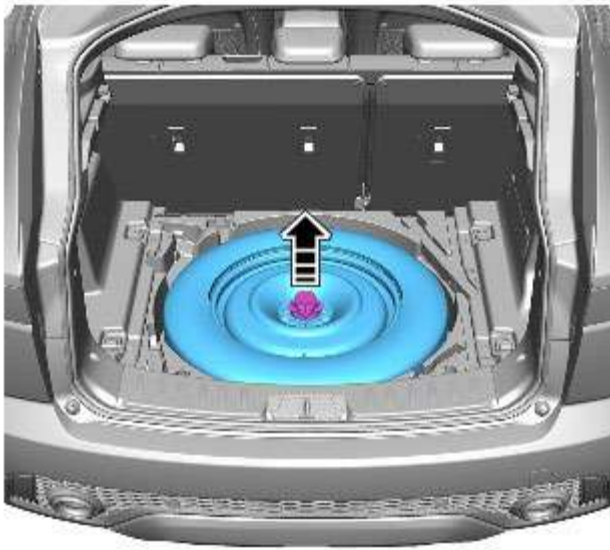
E208818

4.

If installed, release the spare wheel by turning the retainer counter-clockwise and then remove the spare wheel.
