Service Manual: VEHICLE DATA

VEHICLE INFORMATION > INTERNATIONAL VEHICLE CONTROL AND DISPLAY SYMBOLS > DESCRIPTION > DESCRIPTION

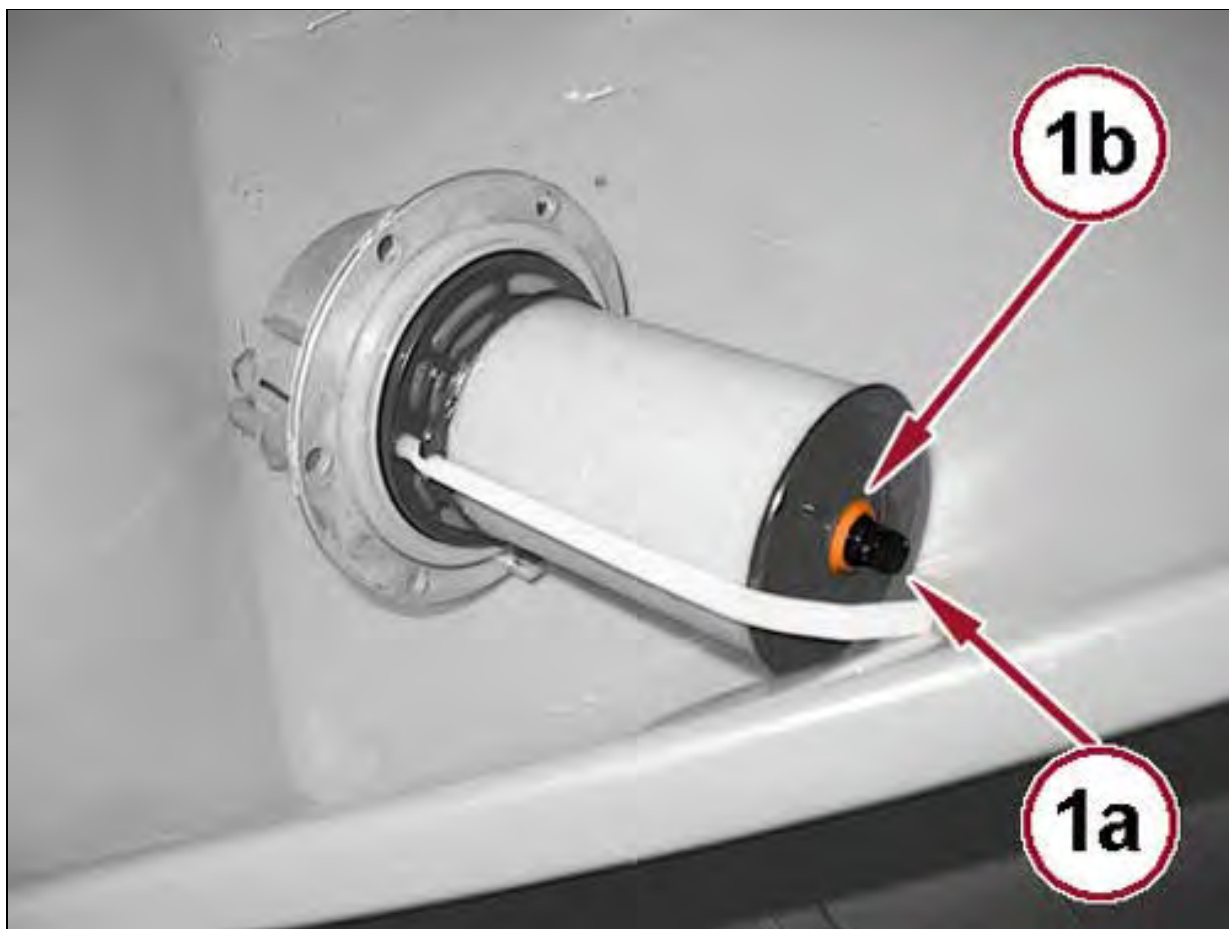
Fig 8: Water Presence Sensor & Seal Ring

- Check the correct position of the water presence sensor (1a) and seal ring (1b).

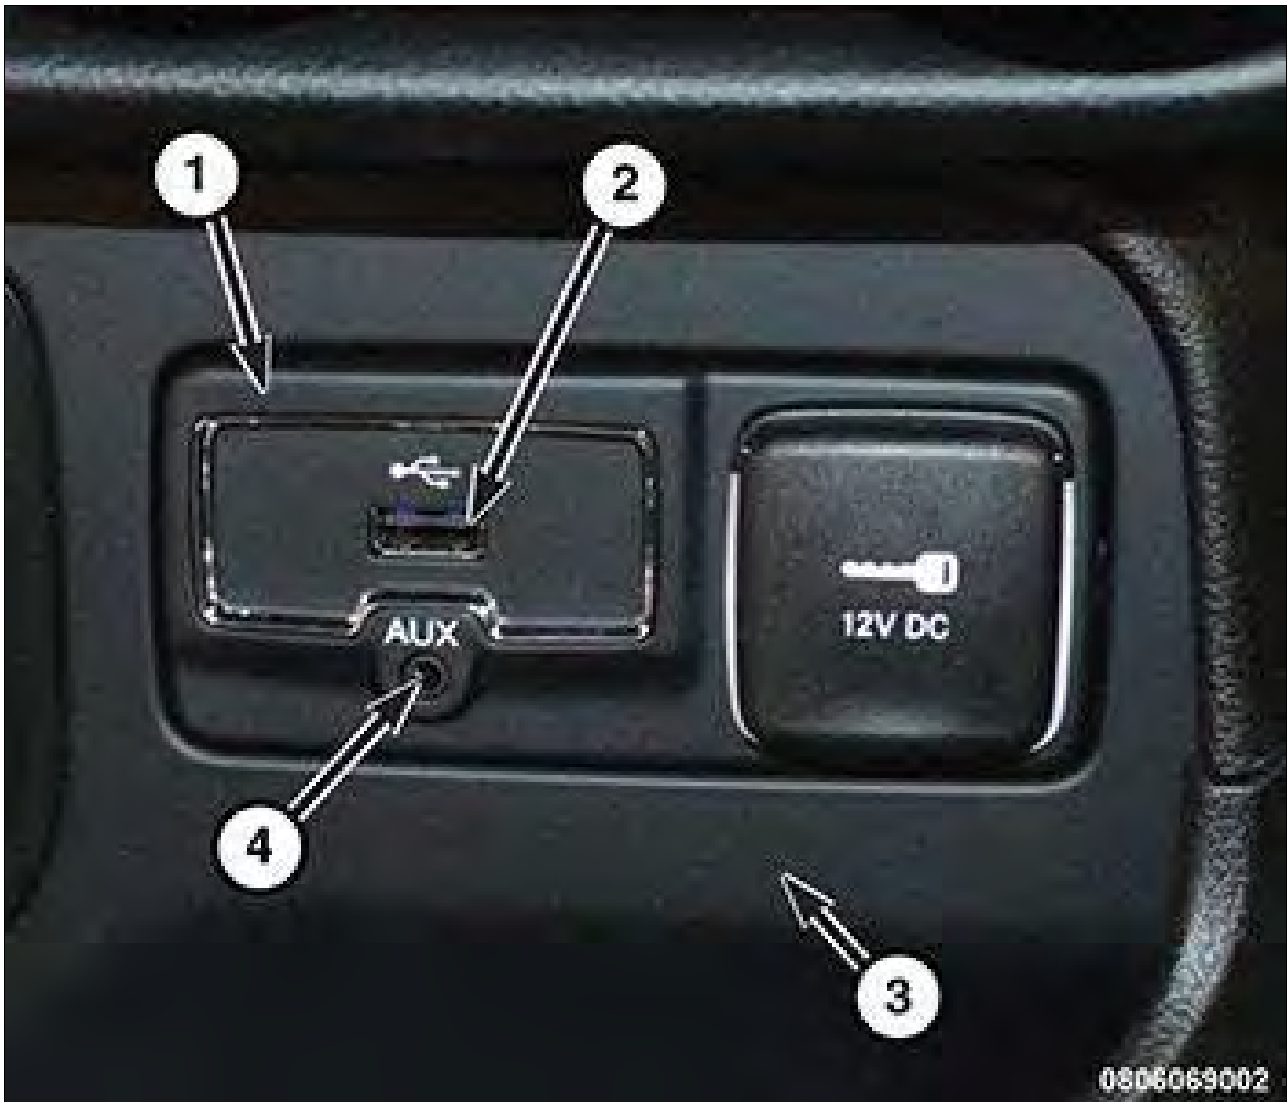
Fig 1: Media Hub

The media hub (1) is located in the forward surface of the center console (3). The media hub is a centralized connection point in the vehicle that contains:

- a 3.5 millimeter auxiliary audio input jack (4)
- a powered USB port (2)

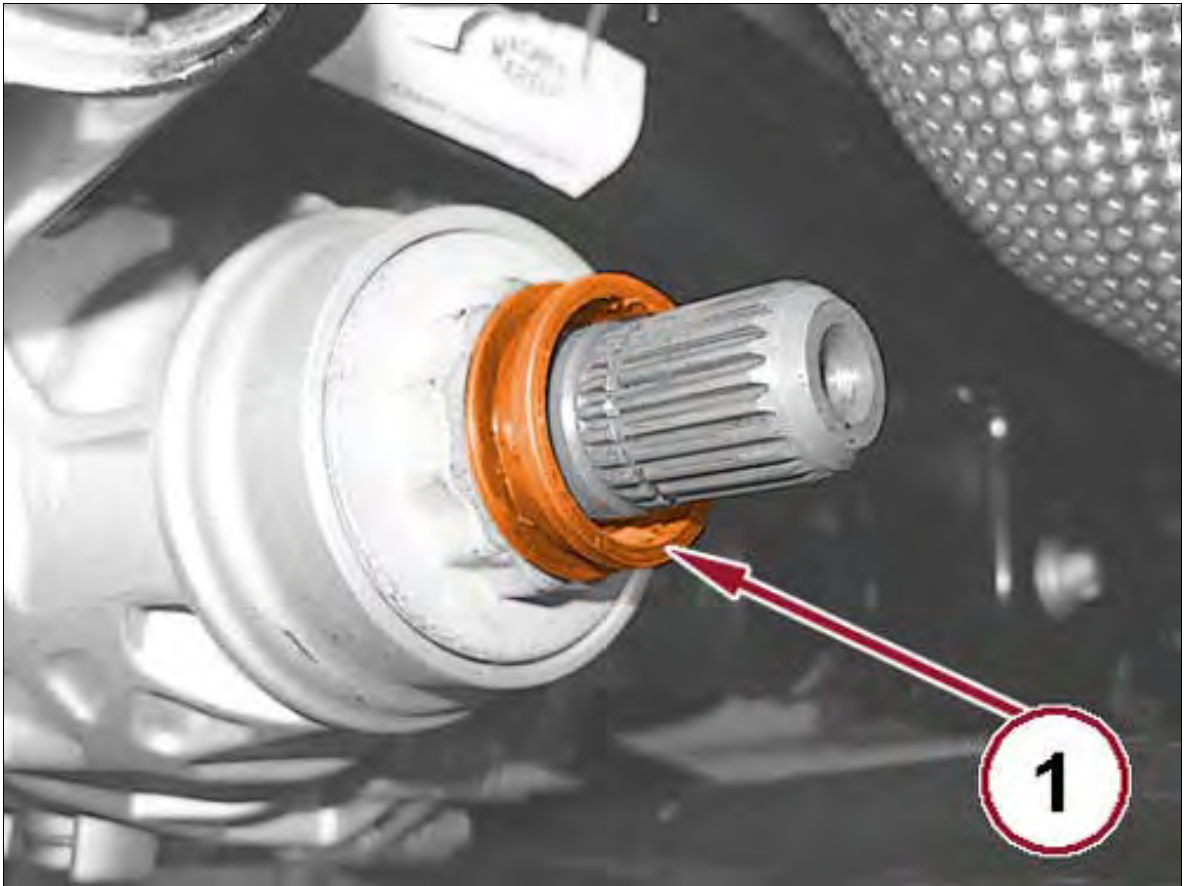
Fig 3: Dust Seal

5. Install a new dust seal (1) on the pinion shaft of the RDU.
