| Last Modified: 11-21-2024 | 6.11:8.1.0 | Doc ID: RM1000000028SPC |
| Model Year Start: 2023 | Model: Mirai | Prod Date Range: [12/2022 - 12/2023] |
| Title: COOLING: WATER PUMP: REMOVAL; 2023 MY Mirai [12/2022 - 12/2023] | | |

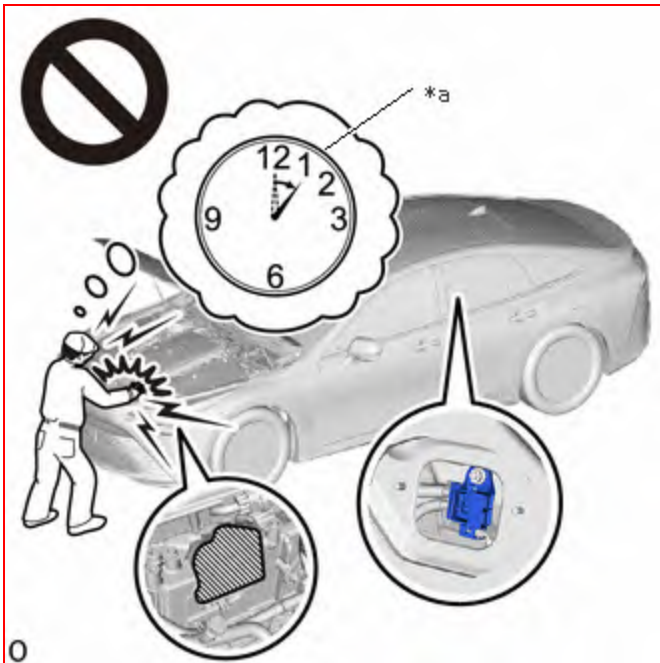
Waiting for at least 10 minutes is required to discharge the high-voltage capacitor inside the inverter with converter assembly and the electric vehicle charger assembly.

| *a | Without waiting for 10 minutes |

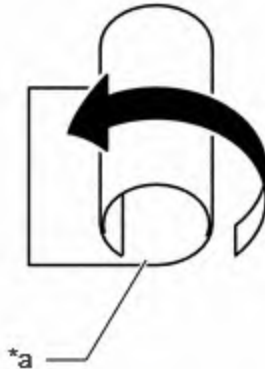
(a) Using a cloth, remove dirt and dust from the FC stack assembly with FC converter surface and around the bolts.

Be sure to perform this work, because it may not be possible to retrieve the bolt if it falls inside the FC stack assembly.

| *a | Paper | *b | Tape |
| *c | Approximately 33 mm | *d | Approximately 110 mm |
